**MUNICIPAL PLANNING COMMISSION AGENDA  
SUMMER VILLAGE OF BIRCHCLIFF  
SUMMER VILLAGES ADMINISTRATION OFFICE  
SEPTEMBER 30, 2021 @ 9:00 a.M.**

**Summer Village of Birchcliff – Municipal Planning Commission****September 30, 2021****Agenda Item****361 Birchcliff Road (Lot 12PT, Block -, Plan 6333KS)****Development Permit Application****Background:**

**SUBJECT:** Slope Assessment  
Screw Pile Installation  
361 Birchcliff Road  
Birchcliff, Alberta

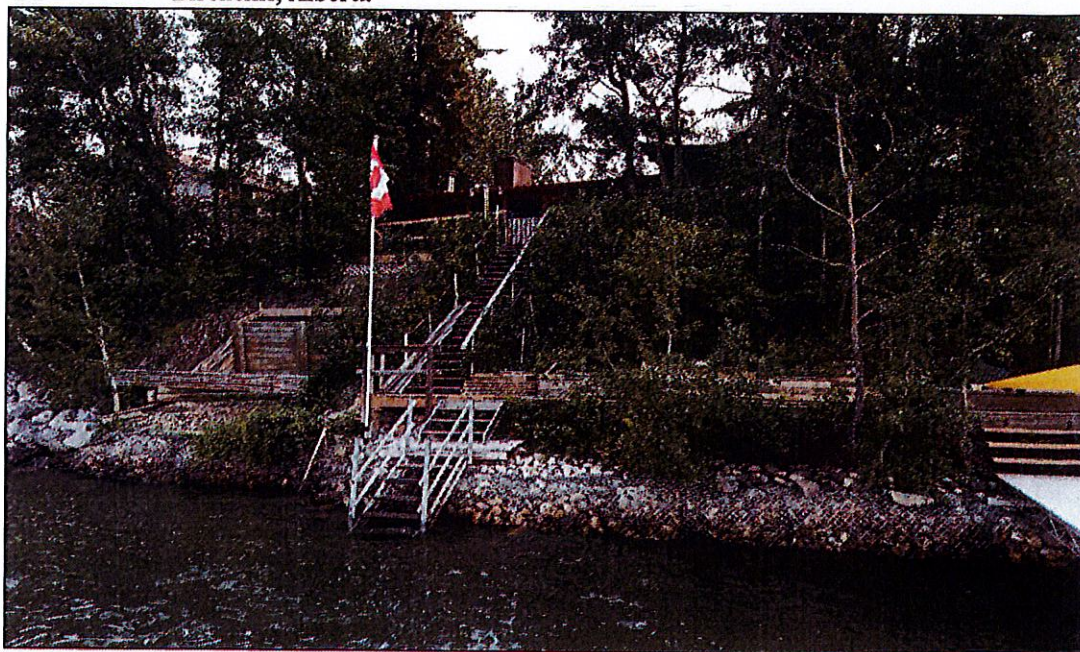
**Photograph No. 1:** Photograph taken from Sylvan Lake, facing north, showing the lakefront portion of 361 Birchcliff Road, the slope, remains of the historic deck, residence, stairwell, and existing conditions at the time of the site visit. Photograph taken on 16<sup>th</sup> July, 2021.

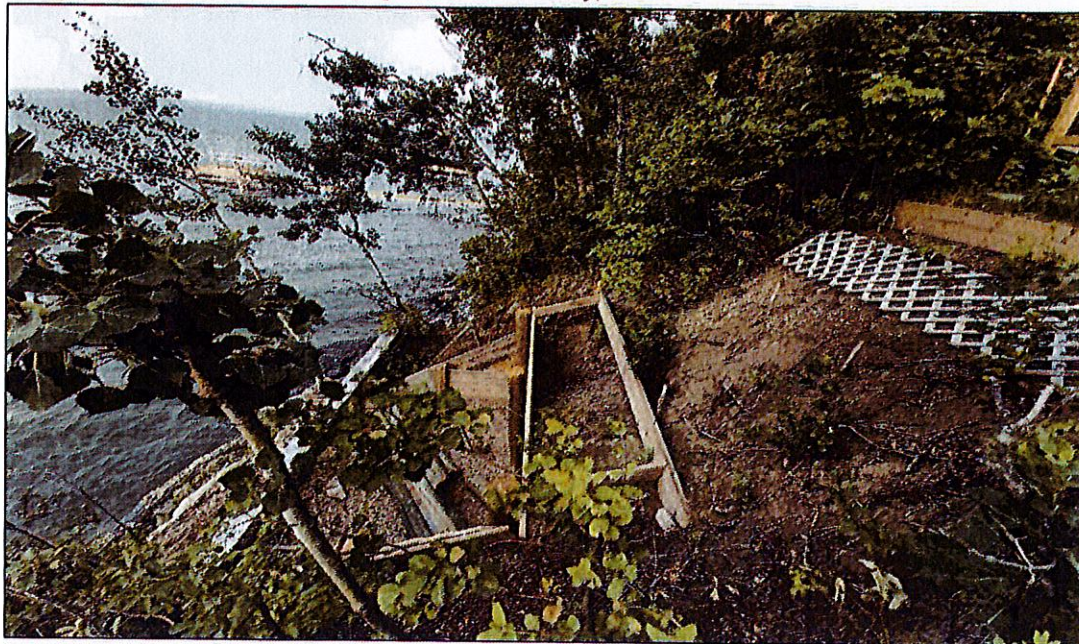
grasses, however, remnants of a historic deck, which was undergoing demolition at the time of the site visit, was located on the western portion of the slope. Portions of the slope in and around the historic deck are not vegetated. A wooden retaining wall structure was observed and some evidence of slope failure, believed to be on the neighbouring property, was visible to the west of the wall.

**Photograph No. 2:** Photograph taken from approximately midway up the existing stairwell, facing west, showing the slope, remains of historic deck, non-vegetated area below historic deck, vegetation to the east and west, and general site conditions observed. Photograph taken on 16<sup>th</sup> July, 2021.

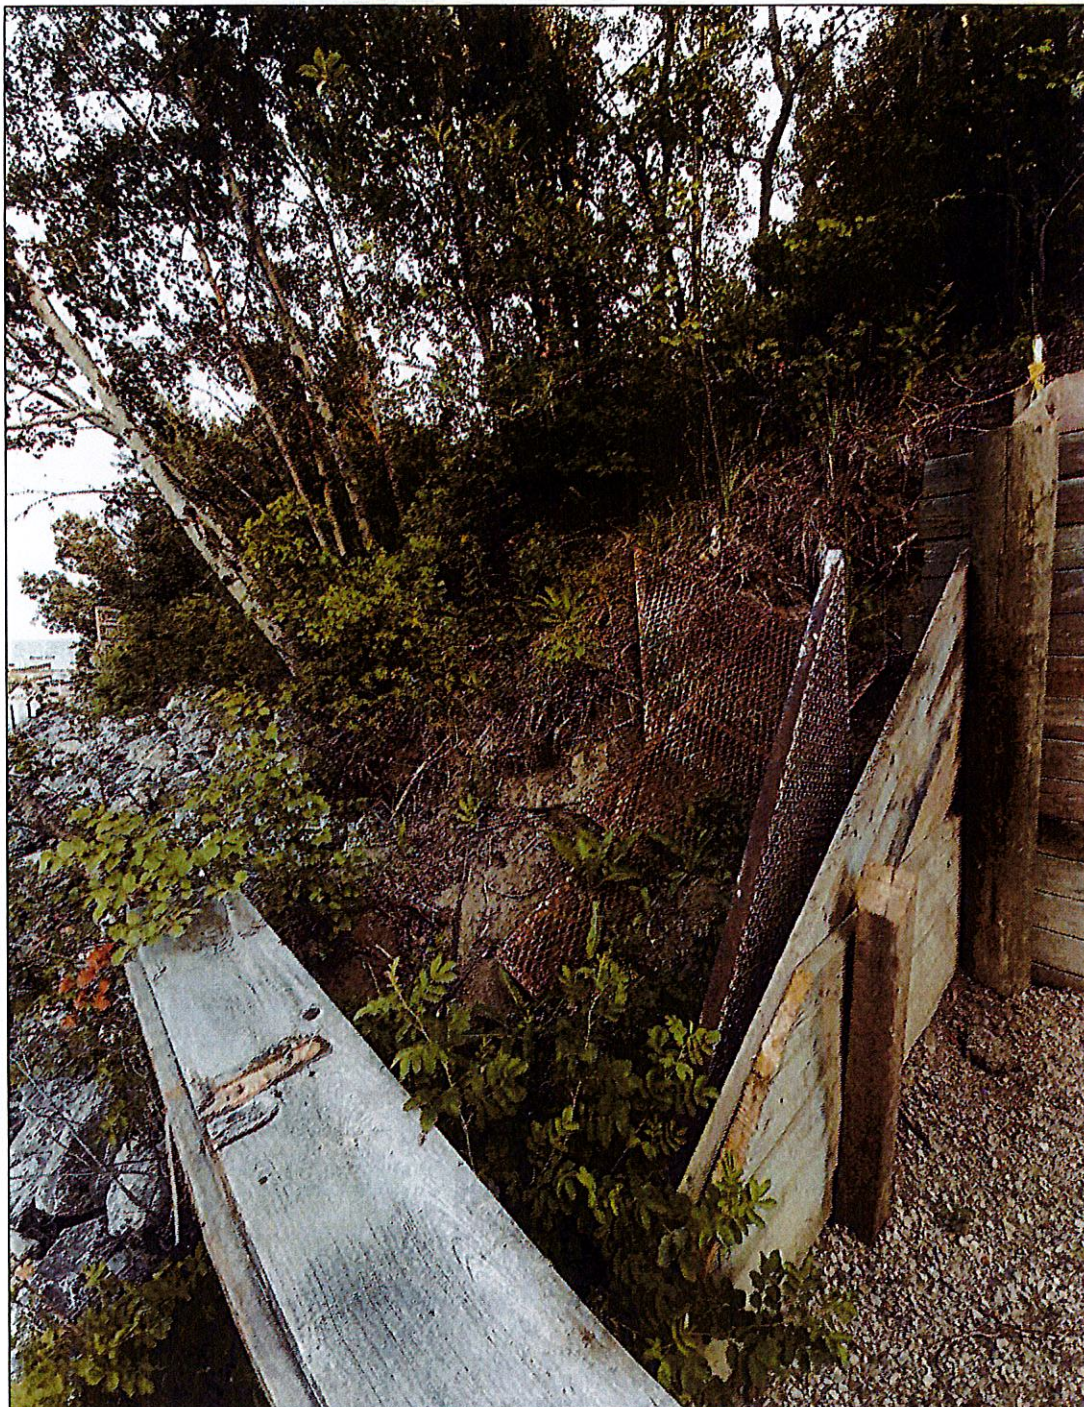
Based on our observation and location of the slope relative to the lake, toe erosion is, or was, undercutting the slope (west of the historic deck), leading to failure and soil movement. It is understood that due to movement and erosion, the homeowner to the west recently re-armoured the toe.

Some evidence of slope failure was observed on the neighbouring slope to the west but it is understood the property owner is in process of implemented a remedial plan with the intent of stabilize that portion of the slope.

**Photograph No. 3:** Photograph taken from near the toe of the slope, within the historic deck footprint, facing northwest, showing evidence of recent slope movement. Photograph taken on the 16<sup>th</sup> July, 2021.
