**MUNICIPAL PLANNING COMMISSION AGENDA
SUMMER VILLAGE OF BIRCHCLIFF
SUMMER VILLAGES ADMINISTRATION OFFICE
NOVEMBER 24, 2022 @ 1:00 P.M.**

101 Birchcliff Road (Lot 3A, Block 2, Plan 8020413)

Development Permit Application

**Proposed Slope Stabilization and Retaining Wall Structure
101 Birchcliff Road
Summer Village of Birchcliff, Alberta**

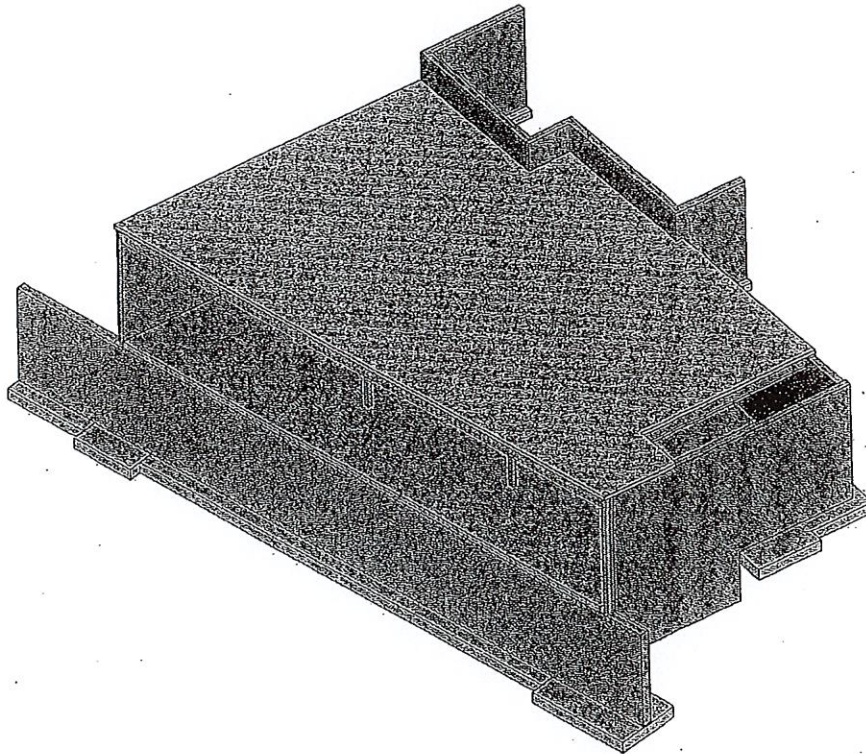
Proposed concrete retaining wall structure

An alternative approach to stabilize the slope is to remove section of the slope and reshape it to improve the slope stability. The section of the slope removed will be replaced with a retaining wall structure consisting of two retaining walls joined together by perpendicular stripped concrete footings, concrete slab and a concrete roof to stabilize the slope and existing structure. (see proposed diagram)

- a) Two concrete retaining walls will be required to maintain the stability of the slope and the existing house.
- b) The first retaining wall in the upper slope with continuous strip footing will be constructed immediately south and parallel to the existing building footing. A minimum horizontal distance of about 1.2 meters should be maintained from the existing house to minimize potential undermining of the existing building foundation soil.

- c) The second concrete retaining wall in the lower slope will be roughly about 3 meters or more within the property line. The continuous strip footing of the second concrete retaining wall will be about the lake water level. Properly installed styrofoam SM insulation is necessary on any footing less than 2.3 meters of soil coverage to prevent heaving of footing foundation.

- d) It is our understanding the two concrete retaining walls will be properly connected by two continuous strip footings with walls on the east and west side to add more lateral support for the concrete retaining walls structure. For added lateral support for the retaining wall structure, foundation walls, concrete roof and a concrete slab will be part of the new structure.

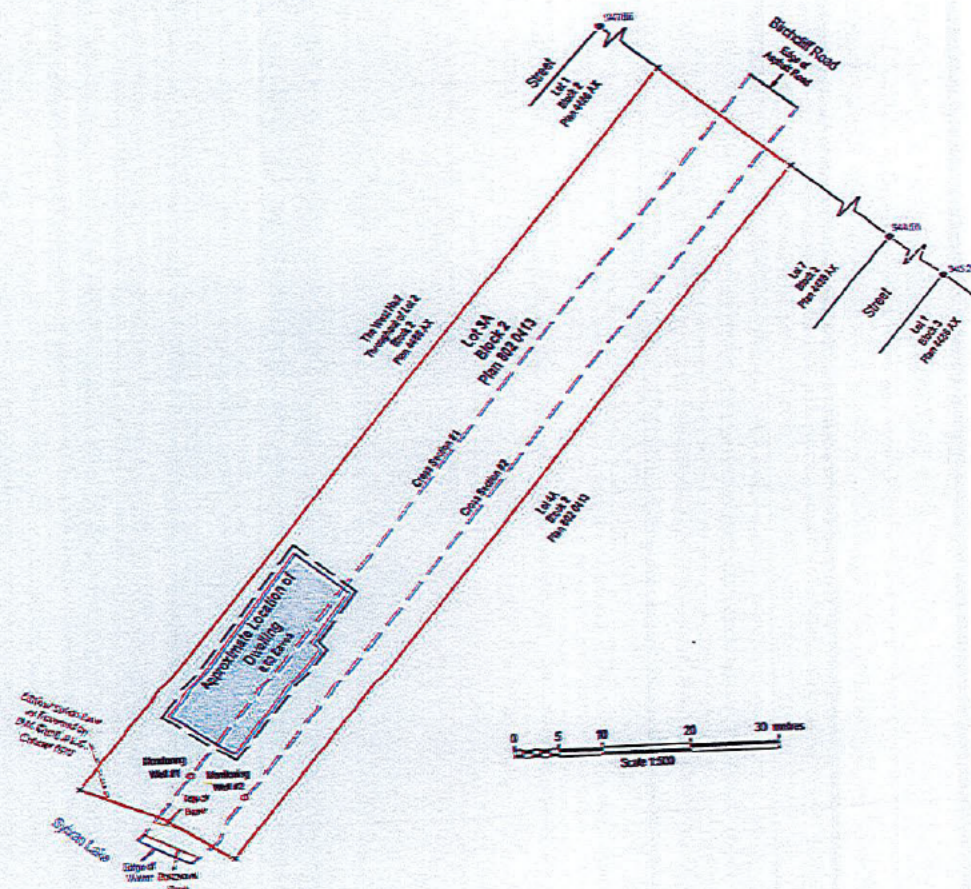
PLAN SHOWING CROSS SECTION #1

The second stage of the slope stability assessment also confirmed a long-term factor of safety (F.S.) of 1.196 for cross section #1 and 1.552 for cross section #2. The F.S. of 1.196 reveal that the cross-sectional profile #1 is only marginally stable. Under these conditions, the cross-sectional profile #2 exceeds the minimum required FS = 1.5.

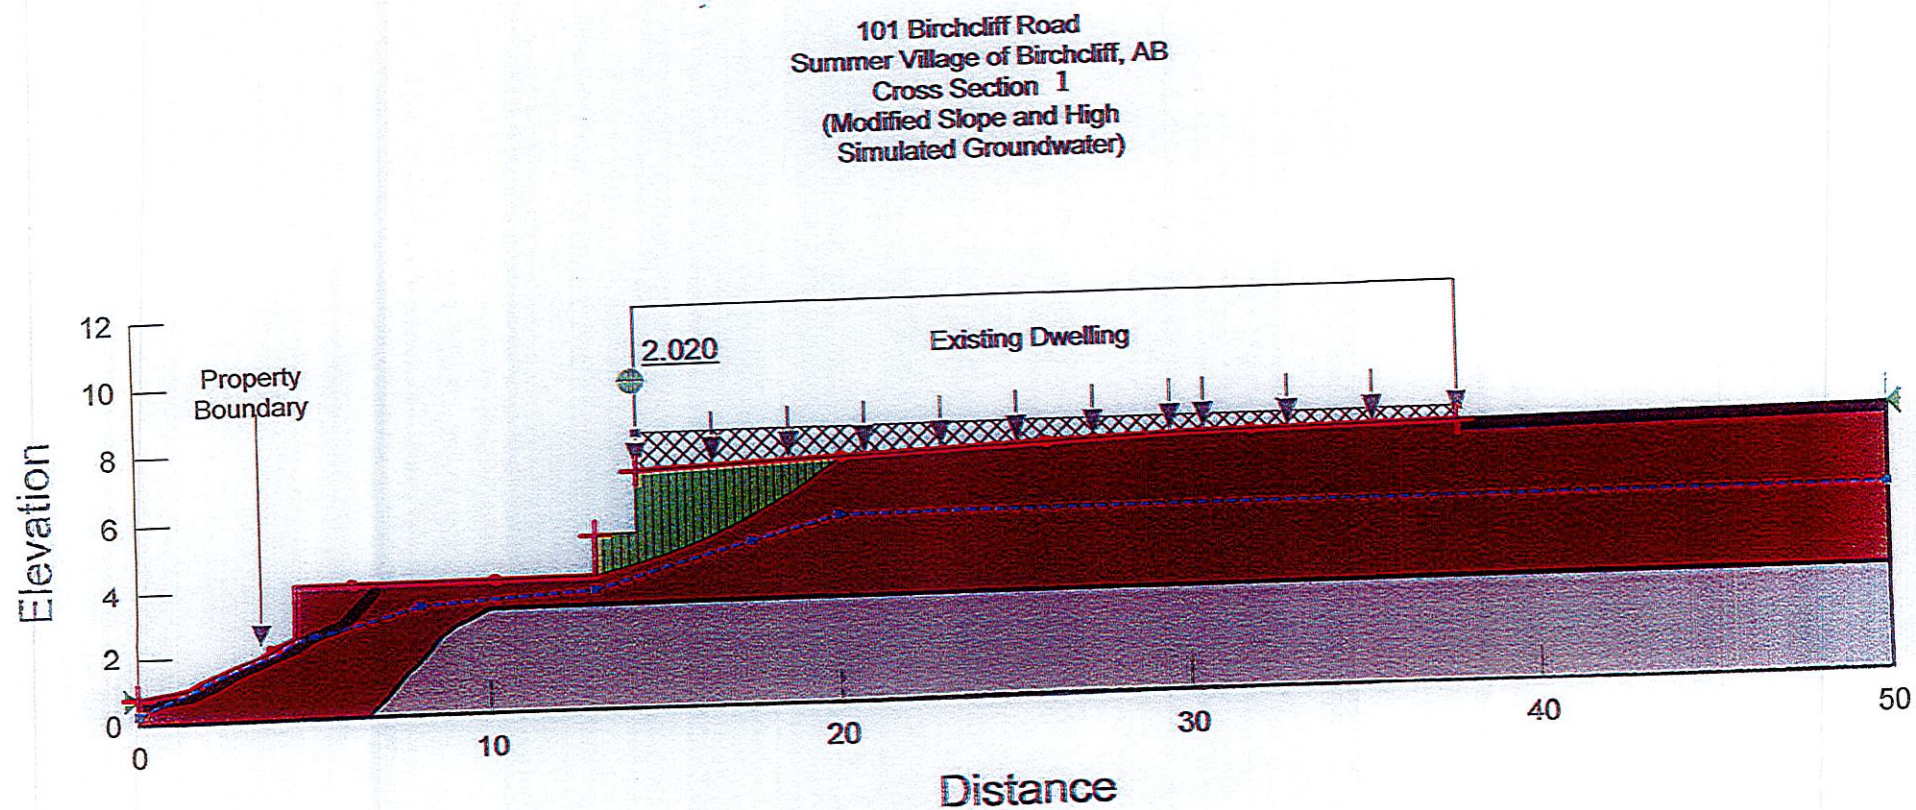
101 Birchcliff Road
Summer Village of Birchcliff, AB
Cross Section: 1
(Modified Slope)

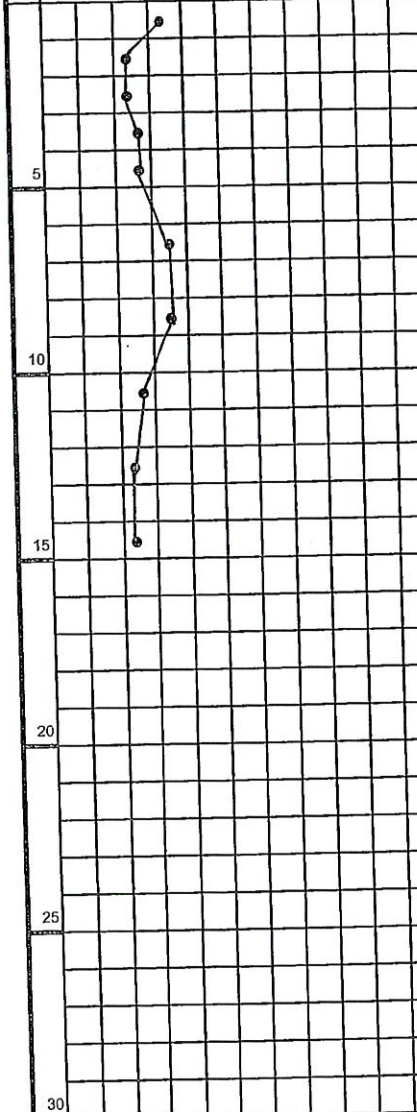
DWG # 3

Fill material, ranging from 1.3 to 2.3 meters thick, was found at hole #2 and #1 respectively. The fill was a mixture of clay, silt, and some sand. The fill at the test hole locations appeared in a firm state.

Native clay till was encountered beneath the fill material. It extended to the bottom of the test holes. The olive brown colored native clay soil was primarily stiff in consistency. The native clay till was characterized with white mineral deposits, stones to pebbles, rusting, grey streaks, coal specks and bedrock fragments. Damp interlayers were noted at occasional elevations within the native clay deposit at borehole #2 only. No damp interlayers were noticed at borehole #1 area.

TEST HOLE LOG AND LAB DATA
