## Consultation Report

File #: FAN-2014-58

Location: Birchcliff Open Spaces, Sylvan Lake

A detailed assessment of the open spaces within the Summer Village of Birchcliff, Sylvan Lake, Alberta was performed on September 30<sup>th</sup>, 2014. The assessment involved creating an inventory of native and invasive plant species, assessing current and future erosion potentials, shoreline modification, and effects of adjacent properties and property owners. The following report presents the results of the assessment and makes recommendations for future planning and land use decisions for the open spaces.

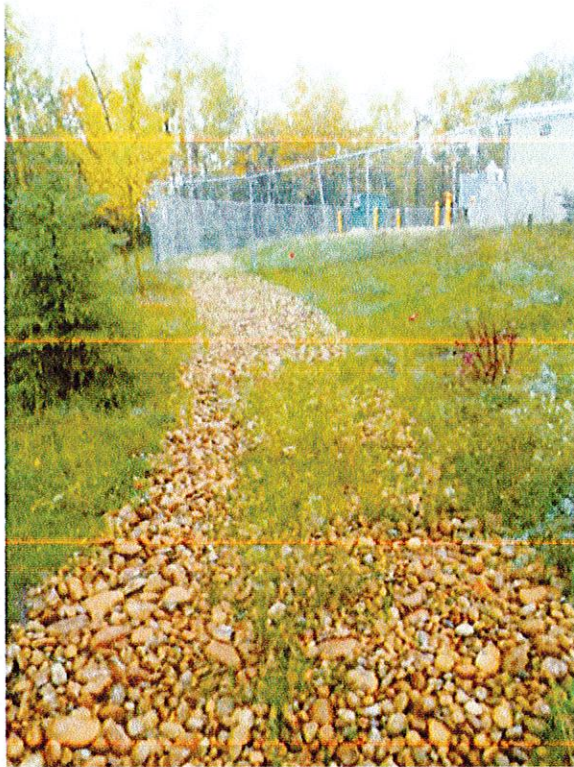
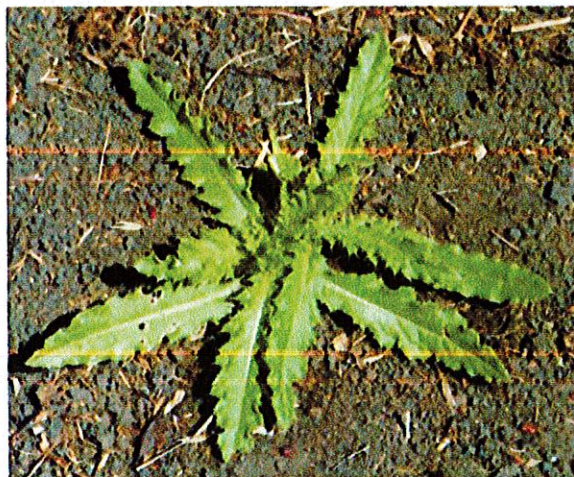
**OS1:**

Site description: This site is on the South East end of the summer village and contains a utility station on its upland portion. Although the area surrounding the utility station has been cleared and disturbed, great steps have been taken to minimize the run-off and erosion potential. The gravel filled swale (right) drains the entire utility site to the road and helps slow the speed of the run-off. Sediment fence has also been installed on the downward side of the site to prevent sediment from flowing off site.

The disturbance caused by developing this site allowed for Canada Thistle to establish. Canada Thistle is a noxious weed that must be controlled according to the Alberta Weed Control Act. This species has reproductive root structure that make it difficult to eradicate. Canada thistle grows and spreads rapidly in full sun. The best long term control in this location will be to hand pick the thistle so that native trees and shrubs can establish. The native plants will grow and shade the Canada Thistle. This will reduce the spread and growth of the Thistle.

- ☐ 1 The shoreline on this site has severe erosion *potential*. Ensure that the native vegetation is not cleared or pruned and avoid any shoreline development
- ☐ 2 Have maintenance workers or site developer's focus on controlling the Canada Thistle and Perennial Sow Thistle that has established before it becomes a significant problem.
- ☐ 3 Allow the area surrounding the utility site to naturalize.

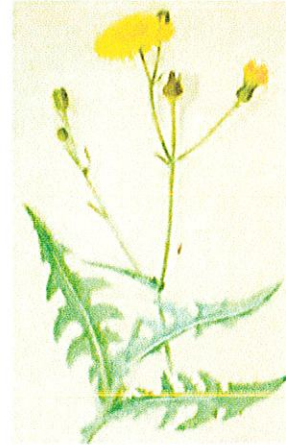
The shoreline portion of this site has a medium length severe slope that is highly susceptible to erosion. The mature forest on the slope helps to prevent erosion on this site. Currently the shoreline has only minor erosion but is significantly protected by the dense vegetation and woody debris. The only downfall of the shoreline on this site is that Perennial Sow Thistle has established. This Noxious weed may cause further erosion and should be hand-picked.

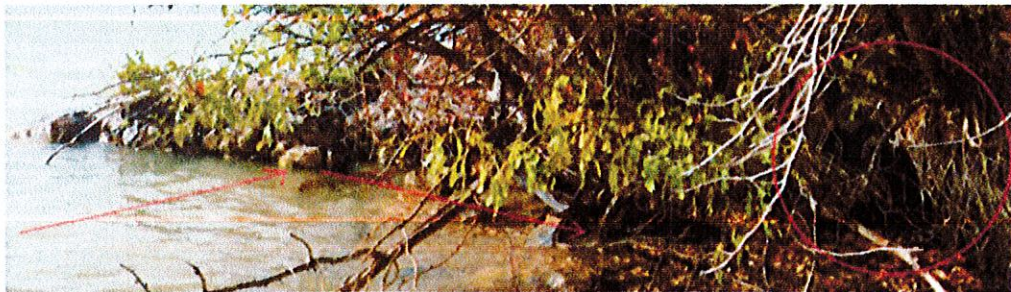
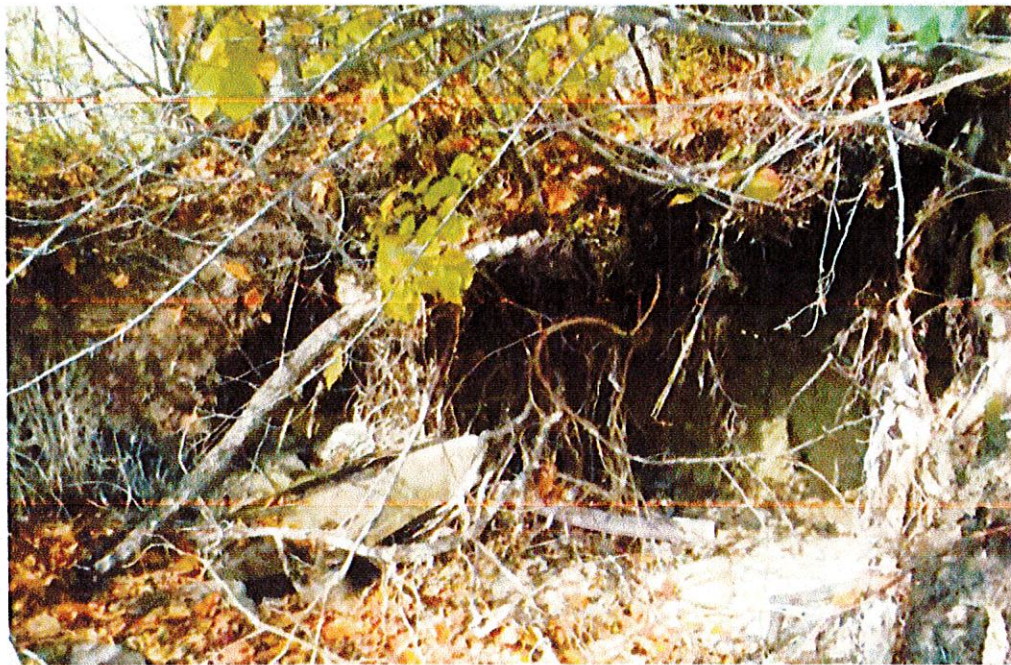
**RA3:**

The upland of this site is covered in dense native vegetation. Closer to the shoreline this changes to an increasing amount of Caragana which outcompetes the native plants. This may be problematic because of the amount of erosion that is occurring on the shoreline area of this site. This site is between two residential lots. The lot to the west has installed gabion baskets to reduce the direct erosion to the property. The problem with the gabion baskets is that they are directing wave energy to RA3 and causing severe bank erosion problems.

The pictures below show how this process may occur and also shows the amount of undercut that has occurred on this bank.

It is difficult to control this level of erosion, however, I recommend that steps be taken to prune the Caragana plants so that native vegetation can recolonize the

area. I also suggest using this area to show residents the effects that hardened shoreline structures can have on native areas near their properties.

- ☐ 1 The shoreline on this site has severe erosion *potential*. Ensure that the native vegetation is not cleared from the upland area.
- ☐ 2 Have maintenance workers or site developer's focus on slowly pruning out the Caragana on this site to allow native vegetation to establish and stabilize the bank.
- ☐ 3 Use this site to show the negative effects that shoreline hardening structures can have on native sites.

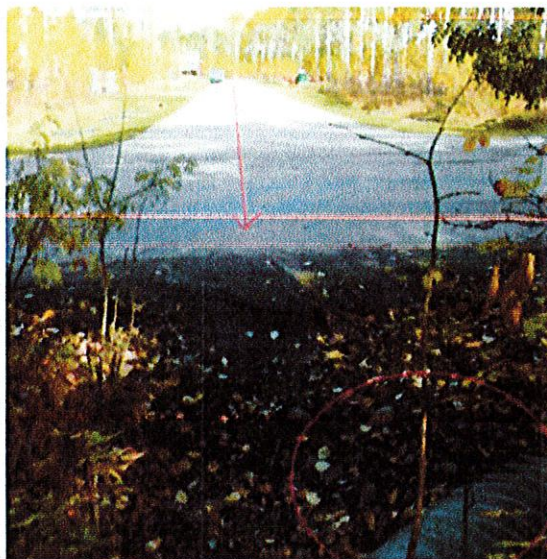
**RA4:**

This site begins at the end of a long paved section of road. It also has a culvert that leads to a drainage ditch on the site. Both of these factors dramatically increase the amount of runoff water coming through the site. Increased water flow leads to an increased risk of erosion of this site. The upside to this site is that it is densely vegetated with native plants which help to reduce the erosion potential. The majority of the site slopes gently towards the shoreline until the final portion which becomes quite steep.

The final steep section of this site is predominantly covered in dense Caragana. This may be a problem in the future and I suggest slowly pruning this out so that native plants can reestablish.

- ☐ 1 The shoreline on this site has severe erosion *potential*. Ensure that the native vegetation is not cleared from the upland area.
- ☐ 2 Have maintenance workers or site developer's focus on slowly pruning out the Caragana on this site to allow native vegetation to establish and stabilize the bank.
- ☐ 3 Ensure that shoreline structures such as rip rap or gabion baskets are not used on this site.

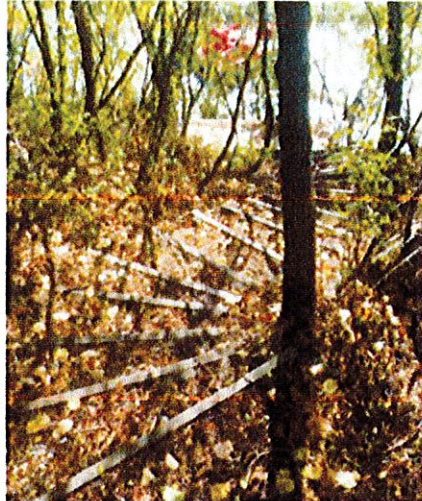
This site is used as shoreline access for back lot residents. The path descending onto the shoreline of this site has had steps installed. This path is curved which helps reduce the chances of erosion. These steps should not be of concern. There is also a significant dock on the shoreline. Make sure that docks on this site are removable and not repainted or cleaned on the water.

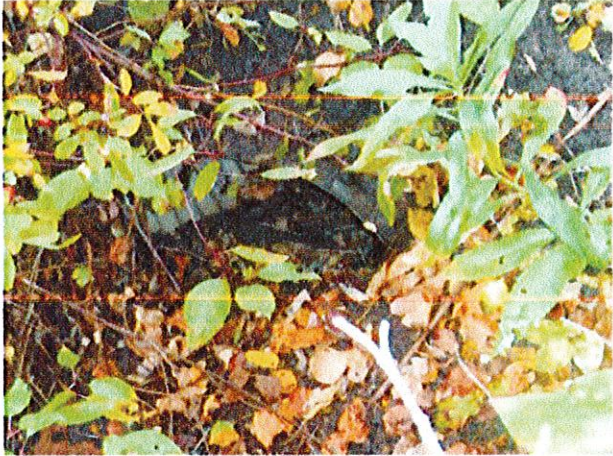
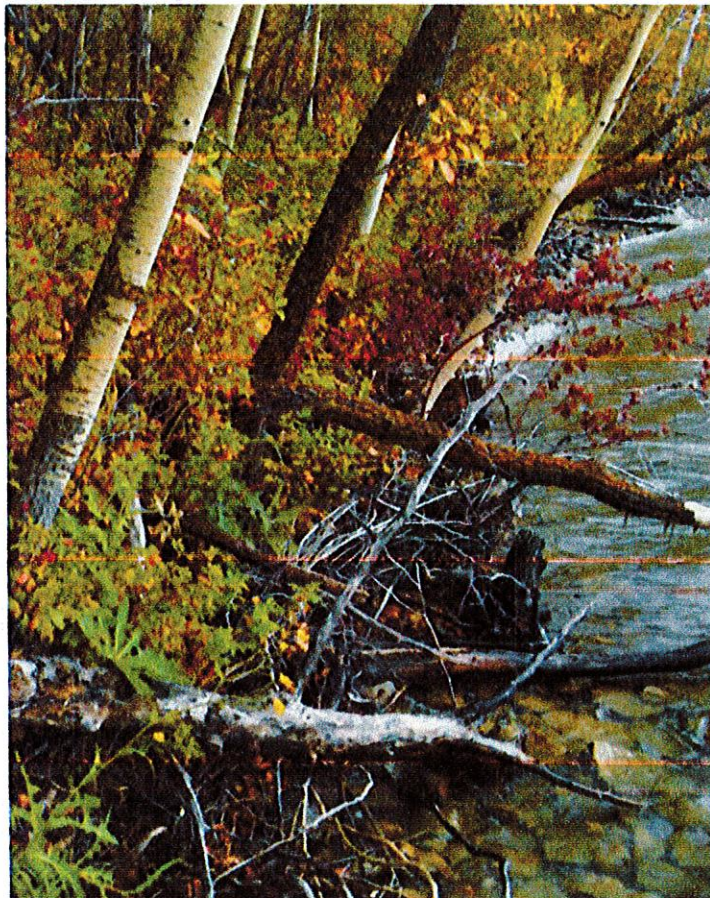
**OS4:**

This site has a culvert that leads to a drainage ditch on the site. This factor increases the amount of runoff water coming through the site. Increased water

flow leads to an increased risk of erosion on this site. One beneficial attribute of this site is that it is densely vegetated with native plants which help to reduce this erosion potential. This site slopes gently towards the shoreline which also reduces the erosion potential. This site has low numbers of Perennial Sow Thistle and Caragana that should be controlled when they are still manageable. Otherwise the site is in great

condition. The shoreline has little signs of erosion, most likely due to the woody debris and thick native vegetation shown below.

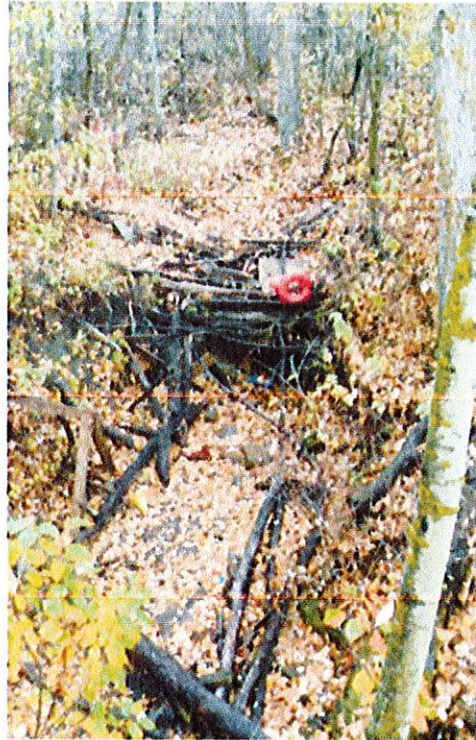
**OS8E, OS8 and OS8W:**

The upland portion of this contains a culvert that leads to a significant drainage ditch. This ditch has signs of significant erosion (right). This erosion may be caused by clearing in the uplands. As shown on the map, the open spaces OS11, OS12, and OS13 drain into this area. These three sites have been cleared of all native vegetation. When native vegetation is cleared, most of the water that would have been used by the plants becomes run-off. This increased water runoff in the uplands may be leading to increased erosion in this area. With increased erosion in this area, invasive species will be able to colonize more easily.

Currently the only invasive species of concern on the shoreline is Perennial Sow Thistle. It should be controlled by hand picking.

- ☐ 1 Try to reduce the amount of water that enters this site through the culvert by vegetating the upland area in open spaces OS11, OS12 and OS13.
- ☐ 2 Make efforts to reduce the number of Perennial Sow Thistle on the site.
- ☐ 3 Consider installing simple steps on the access path before erosion becomes a serious problem on the slope.
- ☐ 4 Remove any ropes on the shoreline trees and make sure users are aware of the problems associated with this practice.

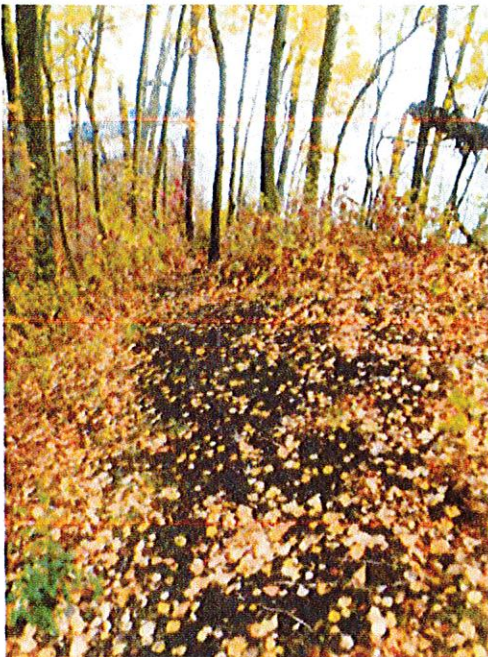
The access path leading down to the water is quite steep and has little vegetation on it (left). The bare soil in this area has a greater chance of being eroded. It may be a good idea to install some simple stairs before the erosion on this slope becomes a concern. Steps like the ones shown in RA4 would be a cheap and easy way to reduce the erosion on this site.

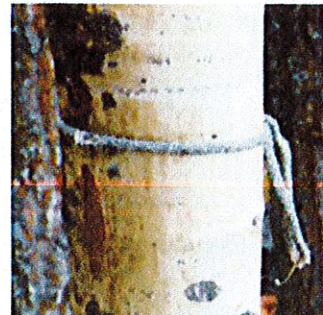
It is also recommended that any rope on trees in the open spaces be removed. Although it seems insignificant, even a small amount of rope will lead to the death of large trees.

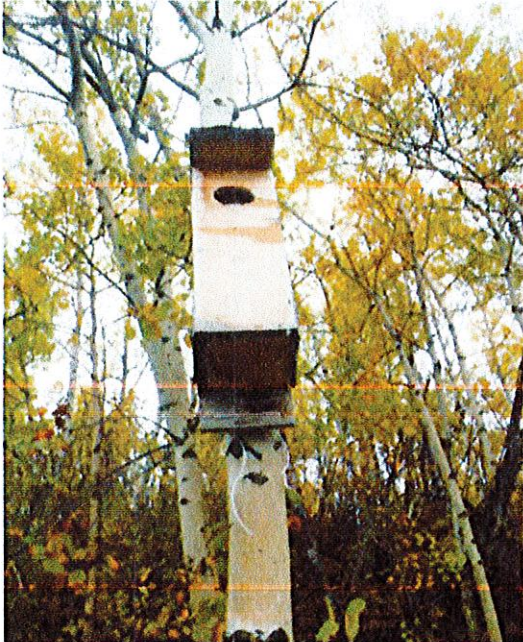
This site has great native and manmade wildlife habitat as shown in the pictures below. The nesting box (below left) has been used by waterfowl and will continue to provide habitat similar to that made by the Pileated Woodpecker. The burrow (below right) would be home to larger ground dwelling mammals.

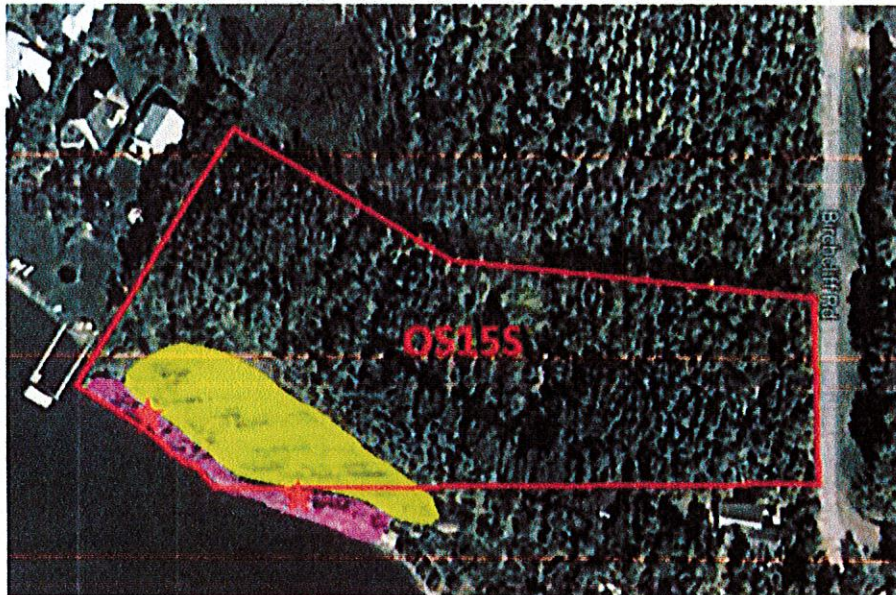
This site contains a **major concern**. The map below helps to illustrate the concern. A legend is provided below.

Red line = Boundary of OS15S

Green area = Wetland

Purple area = Shoreline area of concern

Red star = Sites of Himalayan Balsam (Prohibited noxious weed)

- ☐ 1 Ensure that Himalayan Balsam is eradicated from this site and adjacent homeowners know about the weed. There should also be an annual check for this weed.
- ☐ 2 Make efforts to reduce the number of Canada Thistle plants on the site.

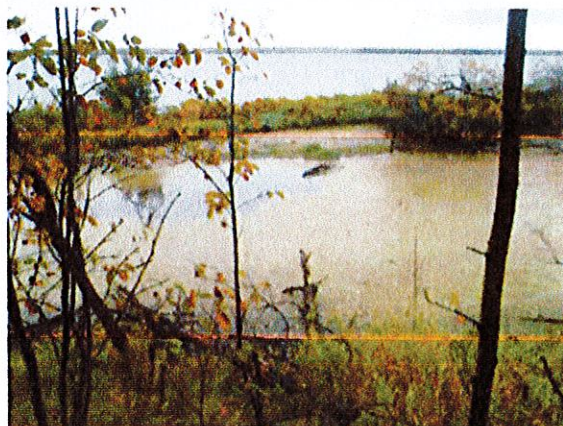
The wetland portion of this site seems to be below the water level of the lake. The purple area shown above is a small shoreline berm that separates the lake from the wetland. The berm is composed of highly erodible sand that is covered in dense vegetation.

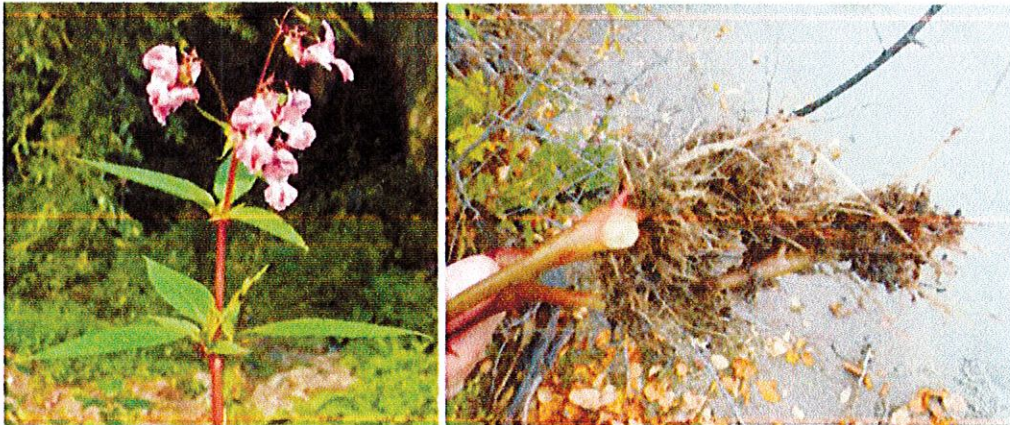
One of the plants on this berm is a prohibited noxious weed called Himalayan Balsam. Prohibited noxious weeds must be eradicated from this site under the Alberta Weed Control Act. The plant was observed in two areas shown by the red stars on the map. One of which was on the property east of the open space. Himalayan Balsam (below) is an annual weed, which means that it grows from seed each spring and dies in the fall. When the plant dies, the roots (below) die and do not provide any structure to the soil under the plant. This makes the area extremely prone to erosion. This small berm is the only feature separating the lake and the wetland. The more Himalayan Balsam that colonizes the berm, the higher the potential for the berm to be eroded and the wetland turned in to a portion of the lake. Wetlands should be conserved because they are important filters for the lake. Himalayan Balsam can spread rapidly by seed because it is able to expel seeds over long distances. The seeds establish easily in wetland and shoreline areas. I highly recommend that this area be surveyed in detail for the plant and adjacent homeowners be educated about the plant. Fact sheets for Himalayan Balsam are available on the following site. <https://www.abinvasives.ca/fact-sheets>

- *Himalayan Balsam*  
Ensure that the Himalayan Balsam on site OS15S is eradicated. This plant will pull very easily but may persist as seed until the next few summers. If this plant spreads on this sensitive area, major erosion may occur on this site.

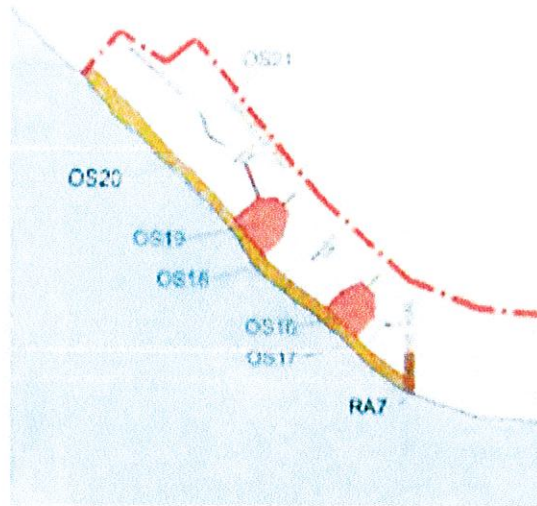
**OS17, OS18 and OS20:**

Most of the bank visible from the staircase is covered with clumped-dense vegetation which provides adequate cover for the shoreline. It was evident that residents who bordered OS20 had manipulated the natural area by building hardened structures on the shoreline. These hardened

structures often protect shorelines that have been cleared of their native vegetation. The problem with hardened structures is that rather than absorbing and reducing wave energy, they deflect wave erosion onto the native shoreline. Over time, hardened structures lead to high levels of erosion on the adjacent native shoreline sites. I suggest that an inventory of shoreline development is created so that future alterations must be regulated and done correctly.

- ☐ 1 This shoreline on this site has severe erosion *potential*. Ensure that the native vegetation is not cleared or pruned and avoid any shoreline development.
- ☐ 2 Make an inventory of current shoreline development in Birchcliff. This will make sure that any future shoreline development is regulated and done correctly.
- ☐ 3 In the spring check that the docks in this area have not become victims of the lake ice. The abandoned docks in this area are becoming unsightly and unnecessary.

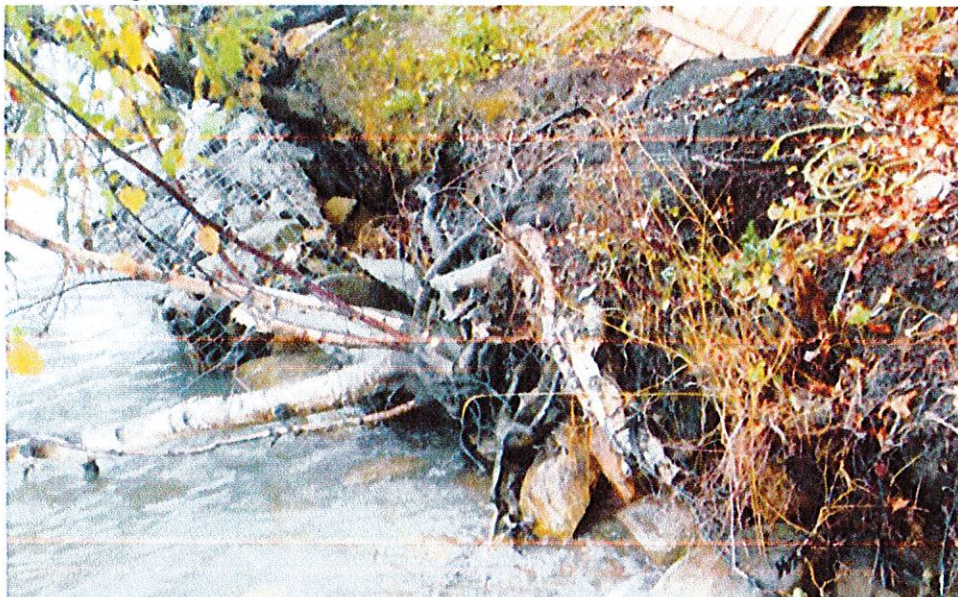
The photo below shows some of the effects that gabion baskets combined with lack on vegetation have on the shoreline at the base of the access stairs.

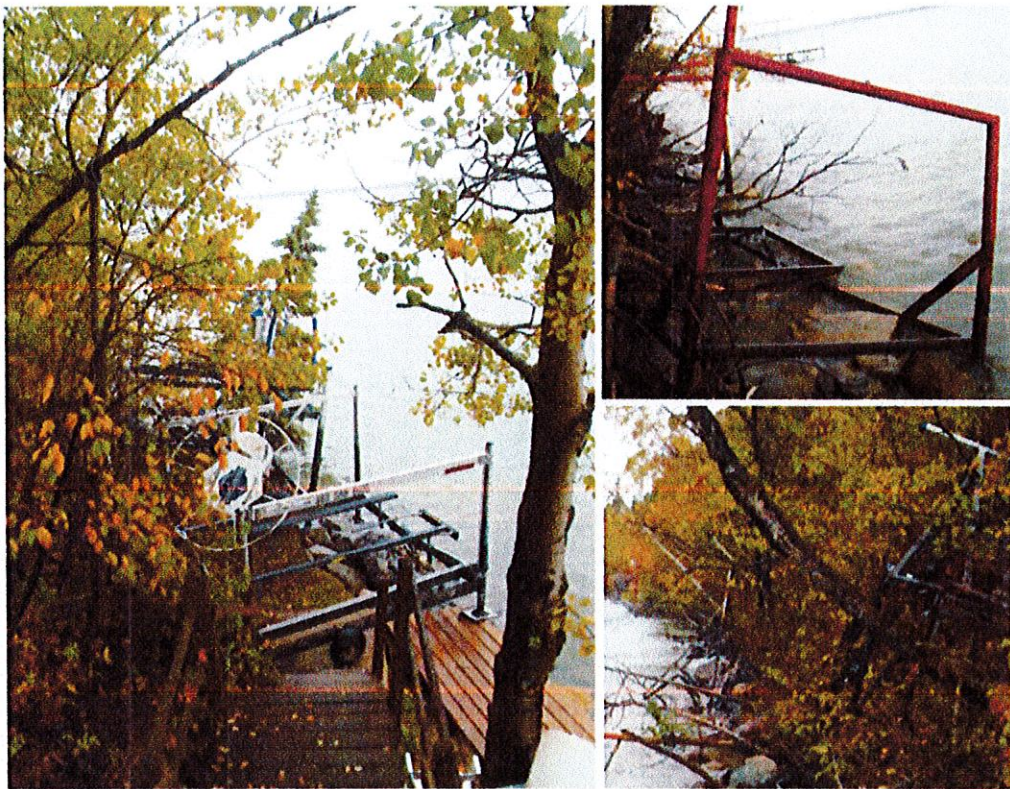
The area accessed by the staircase has been leveled and acts as a storage location for two docks (below left). The problem with this is the potential for damage and movement by ice. Along with these two functioning docks were many other docks (below right) that had been damaged by ice and pushed up into the trees.

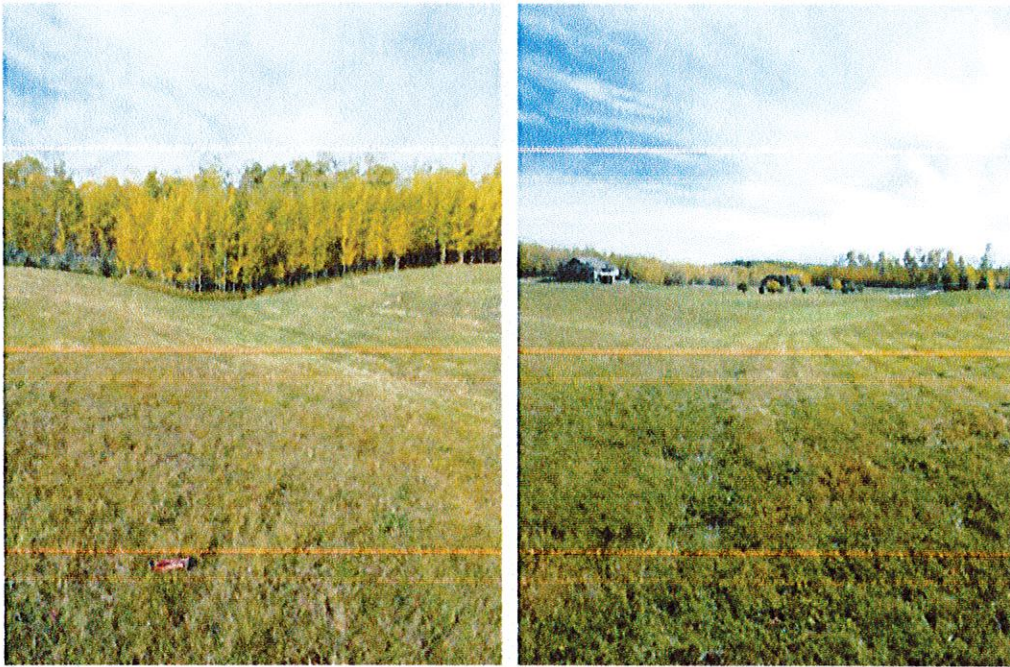
**OS9, OS11, OS12 and OS13:**

These sites have been cleared to develop the area for housing. The sites act as a significant drainage corridor from the upland area. It is evident from the vegetation and topography that this area experiences high amounts of spring run-off. When there is little vegetation in drainage areas it leads to an increased amount of flow downstream and sediment run-off. Signs of erosion downhill in OS8 give us clues about this increased runoff due to reduced vegetation.

I highly suggest that a portion of this area be naturalized to native trees and shrubs. I've created a map on the next page that shows an area that would benefit from this. The best place to replant is in the low lying area that receives the most moisture. The benefits that this will provide are listed below:

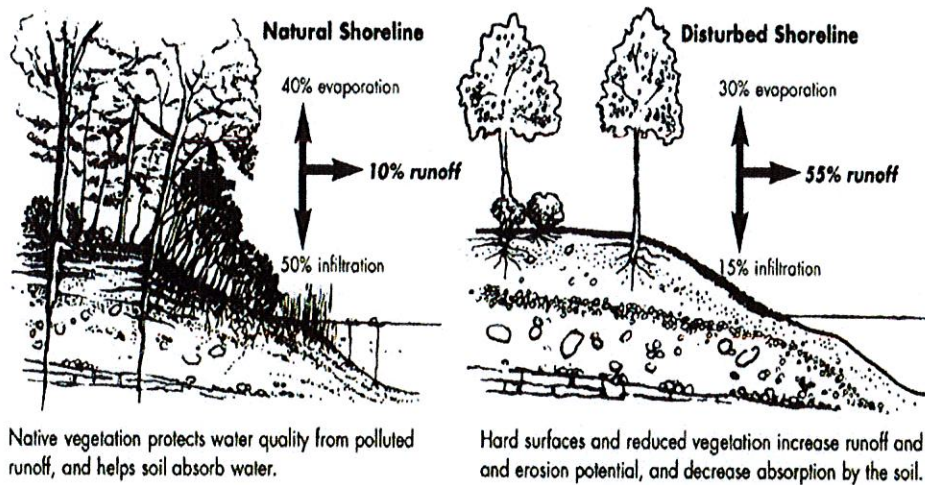
- Increased privacy and reduced traffic noise for the residents surrounding this area.
- Increased wildlife and songbird habitat.
- Reduced spring runoff and flooding in the downstream area (shown in graphic on next page, note the runoff values).
- Reduced nutrient and contaminant flow to the lake which would help maintain lake water quality.
- Reduced mowing/maintenance work in this area.

- *Naturalization*  
Steps should be taken to naturalize sites OS11, OS12 and OS13. Creating restricted mowing zones and planting the suggested native plants are great steps to increase the benefits that this area has on the surrounding ecosystem, including the lake.

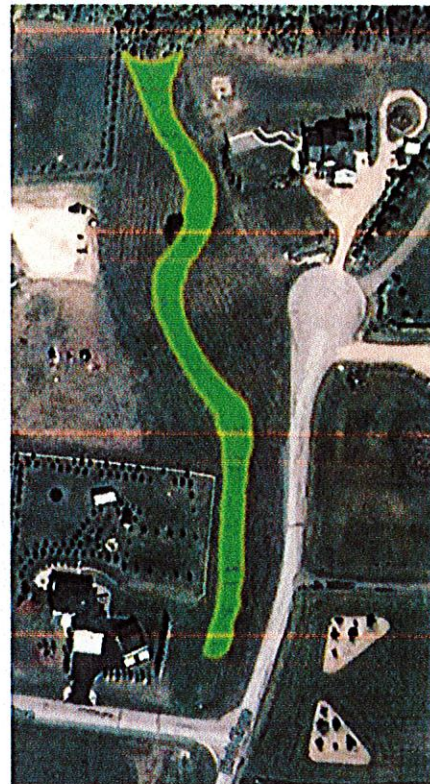
The best way to start naturalizing this area is to select and mark off an area that you are willing to let naturalize. I suggest starting with an area 10-15 meters wide, and close to the entire length of the OS11, leaving a space at the end so that vehicle traffic site lines are not impeded near the intersection at the south end of the subdivision. Mowing in this area should be restricted so that native grasses and forbes can re-establish. This may result in a surge of Canada Thistles at first but these will eventually be choked out by native plants that grow naturally and are planted. I suggest planting Trembling Aspen, Red Osier Dogwood, Wild Rose and native Willow varieties. These plants will be tolerant of the seasonal variability in moisture on this site. These species will also spread naturally so that the area will fill in over time and choke out invasive plants. Planting these species in odd groupings (5, 7, 9) within the green zone shown on the map below will make the area look like it is naturally filling in with native shrubs. A great way to rouse interest in the community is to organize a tree planting day. This also reduces the cost of labour for installing new trees.
