**MUNICIPAL PLANNING COMMISSION AGENDA
SUMMER VILLAGE OF NORGLNWOLD
SUMMER VILLAGES ADMINISTRATION OFFICE
JULY 24, 2023 @ 9:00 A.M.**

111 Grand Avenue (Lot 4-6, Block B, Plan 5108EO)

Development Permit Application

**Proposed Retaining Structures
111 Grand Avenue
Summer Village of
Norglenwold, Alberta**

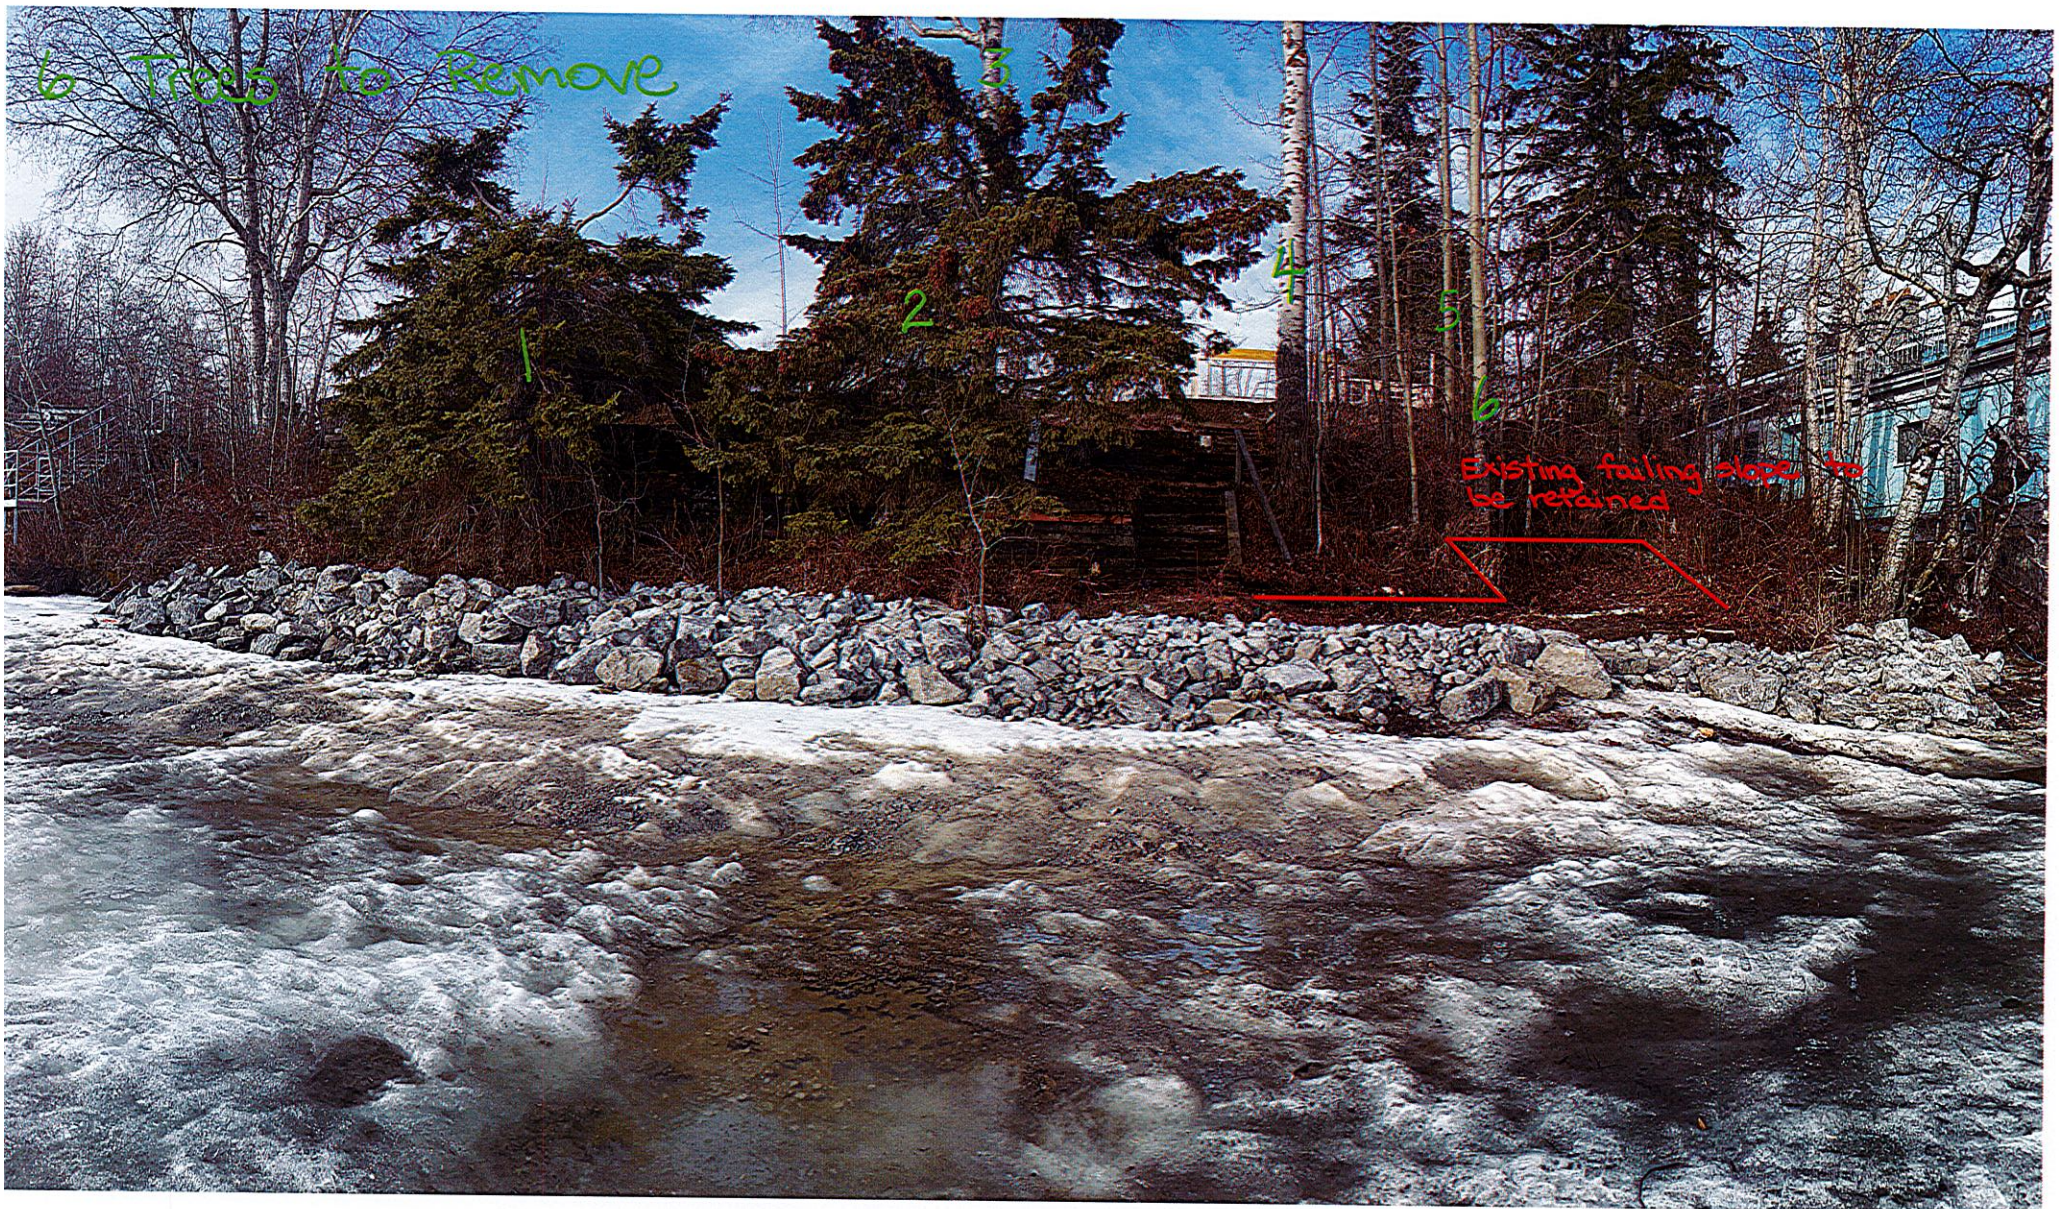
Wall Locations

C-1

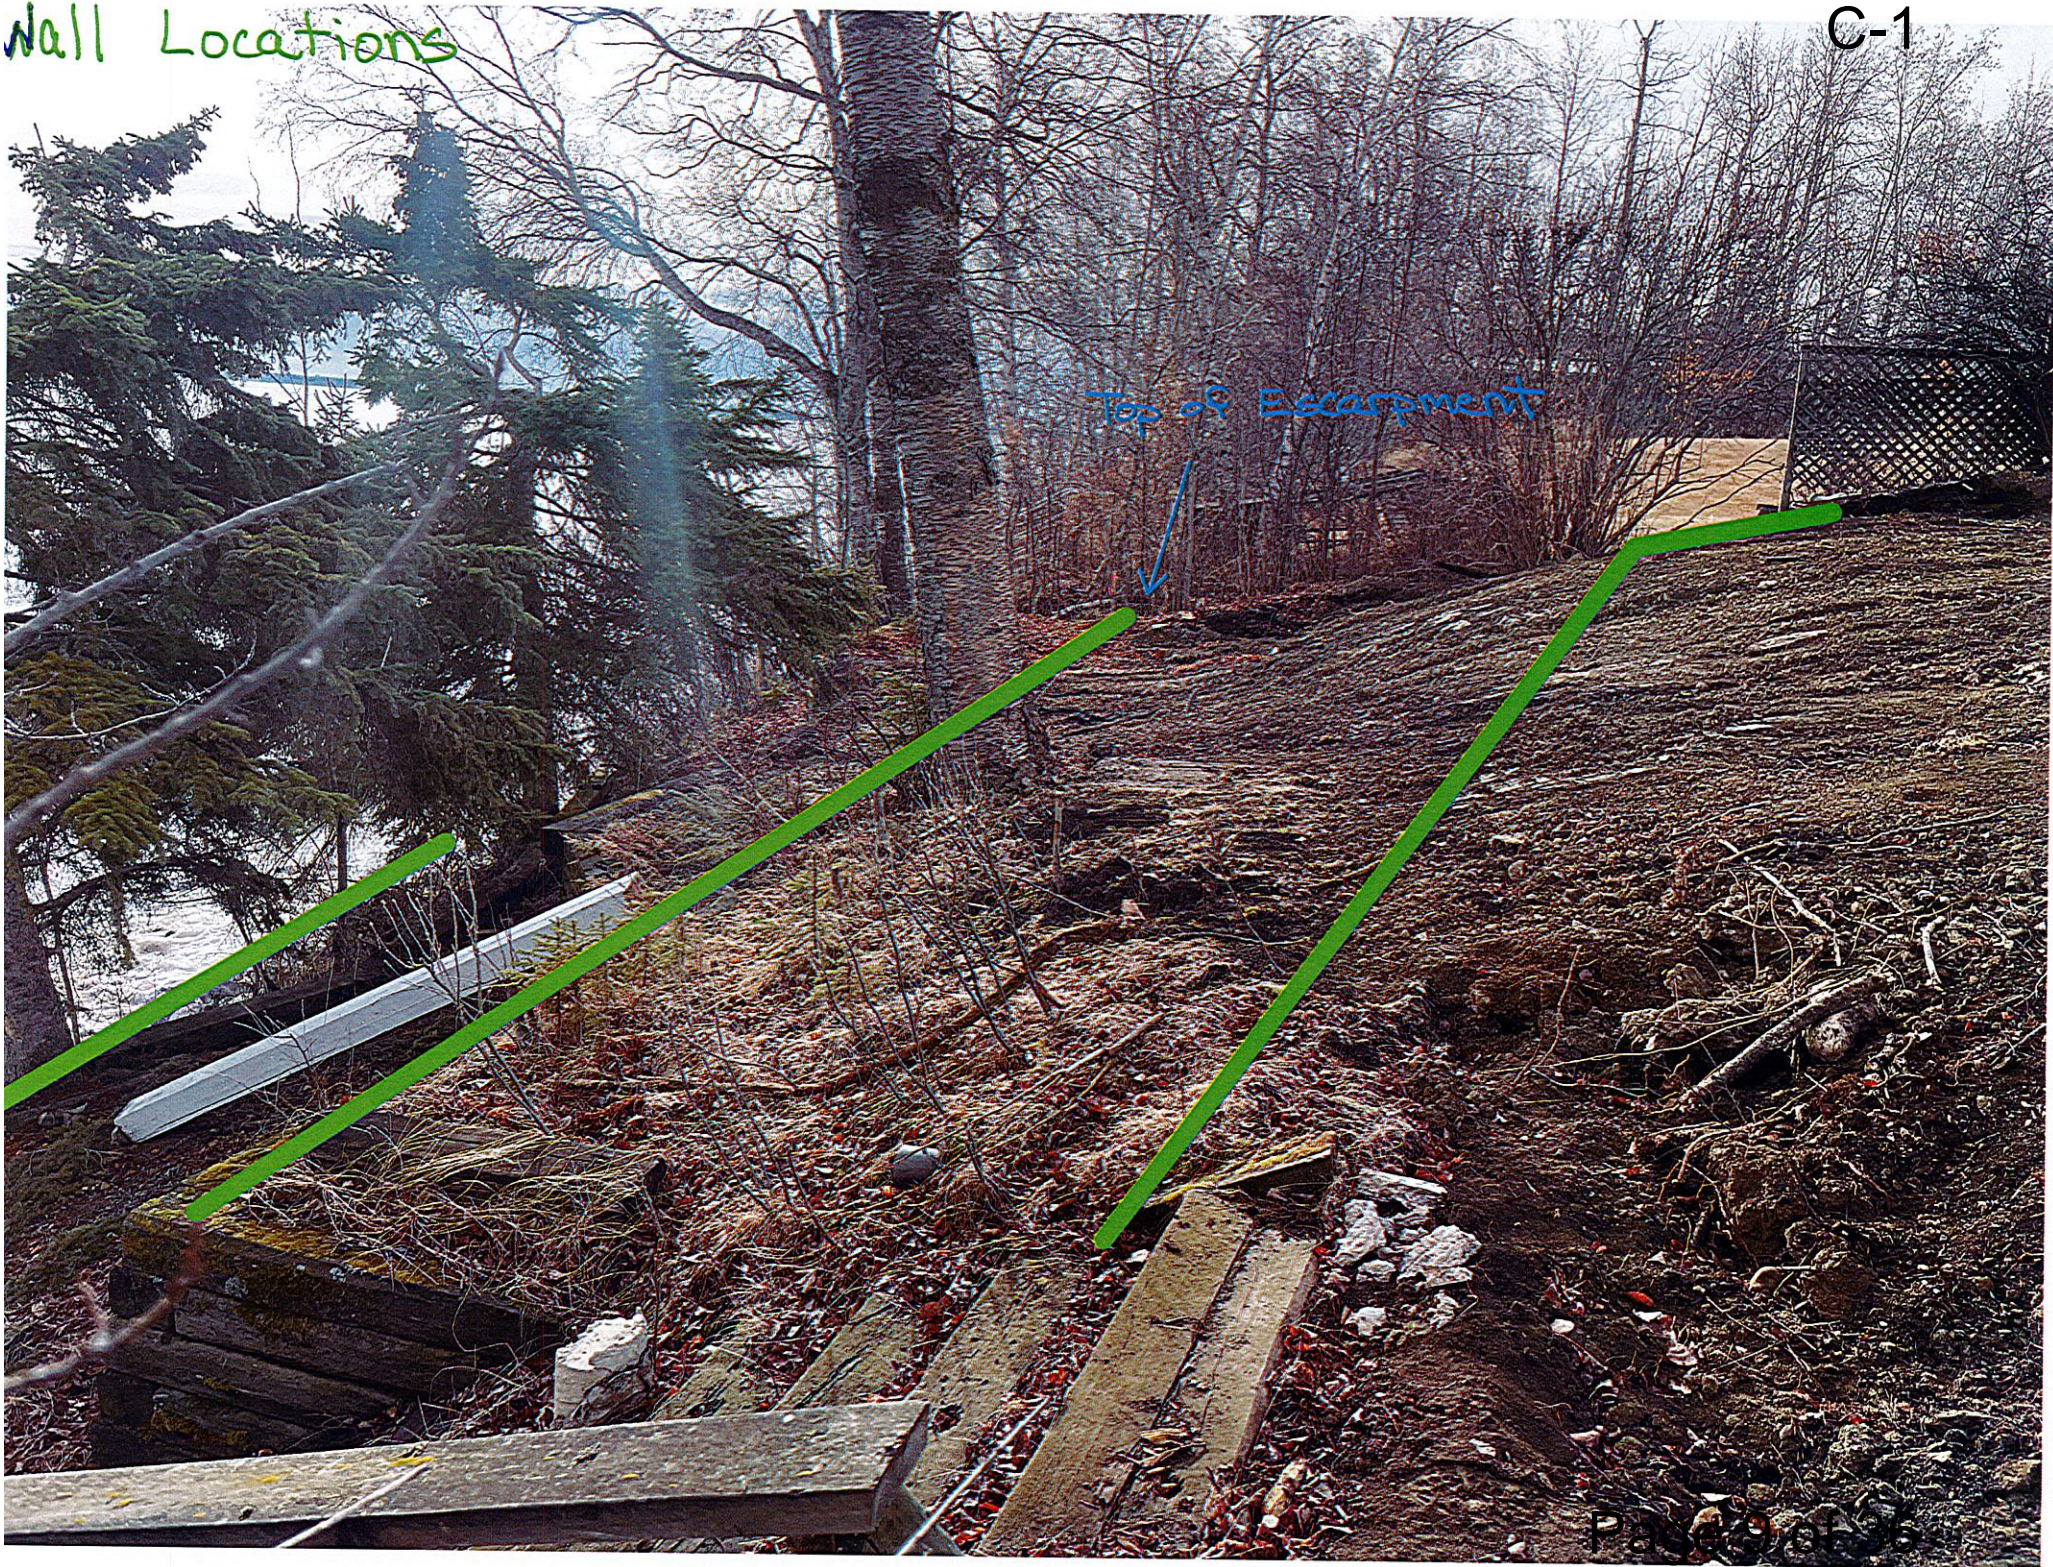
Remove Existing
Railway Tie Walls

No MOW
Zone

The owners of 111 Grand Ave wish to replace the existing railway tie retaining walls with precast concrete blocks. The main purpose of this is to remove the environmental hazard from the lakeshore that is posed by the chemicals used in the preservation of these timbers. It is recommended by Alberta Environment to replace any structures that are built from such materials. A secondary intent is to improve the stability of the escarpment, helping to reduce current erosion and the introduction of sediment into the lake.

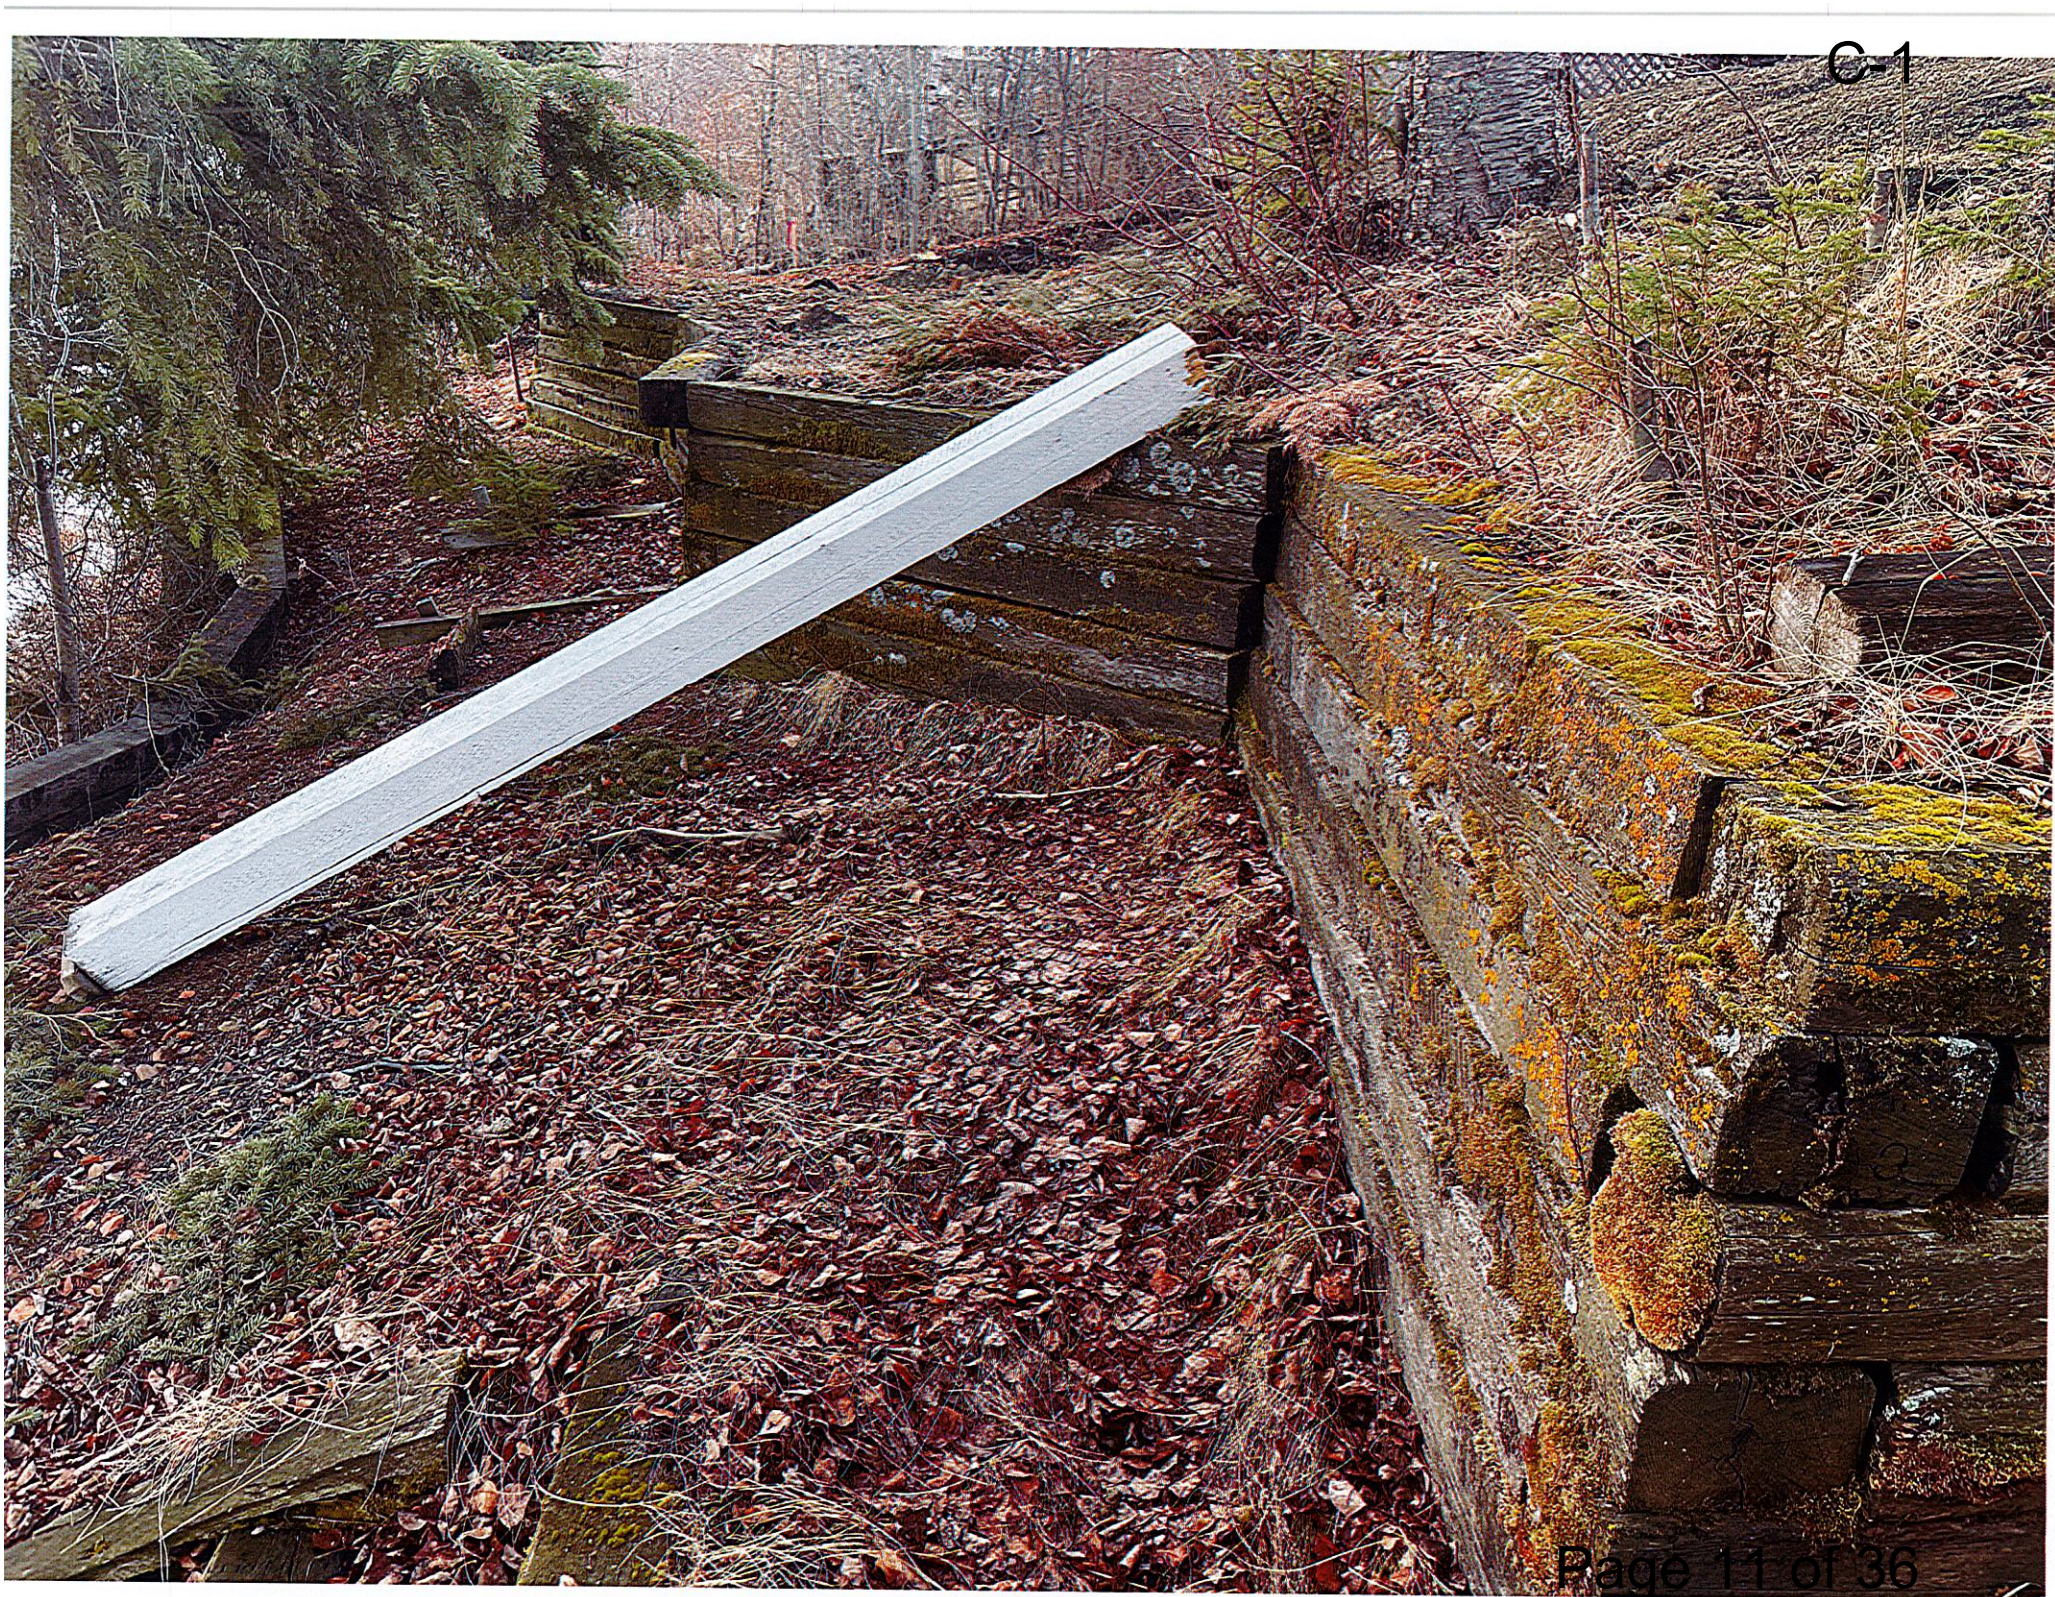
Remove and Replace
Existing Stairs

Neighboring retaining wall location

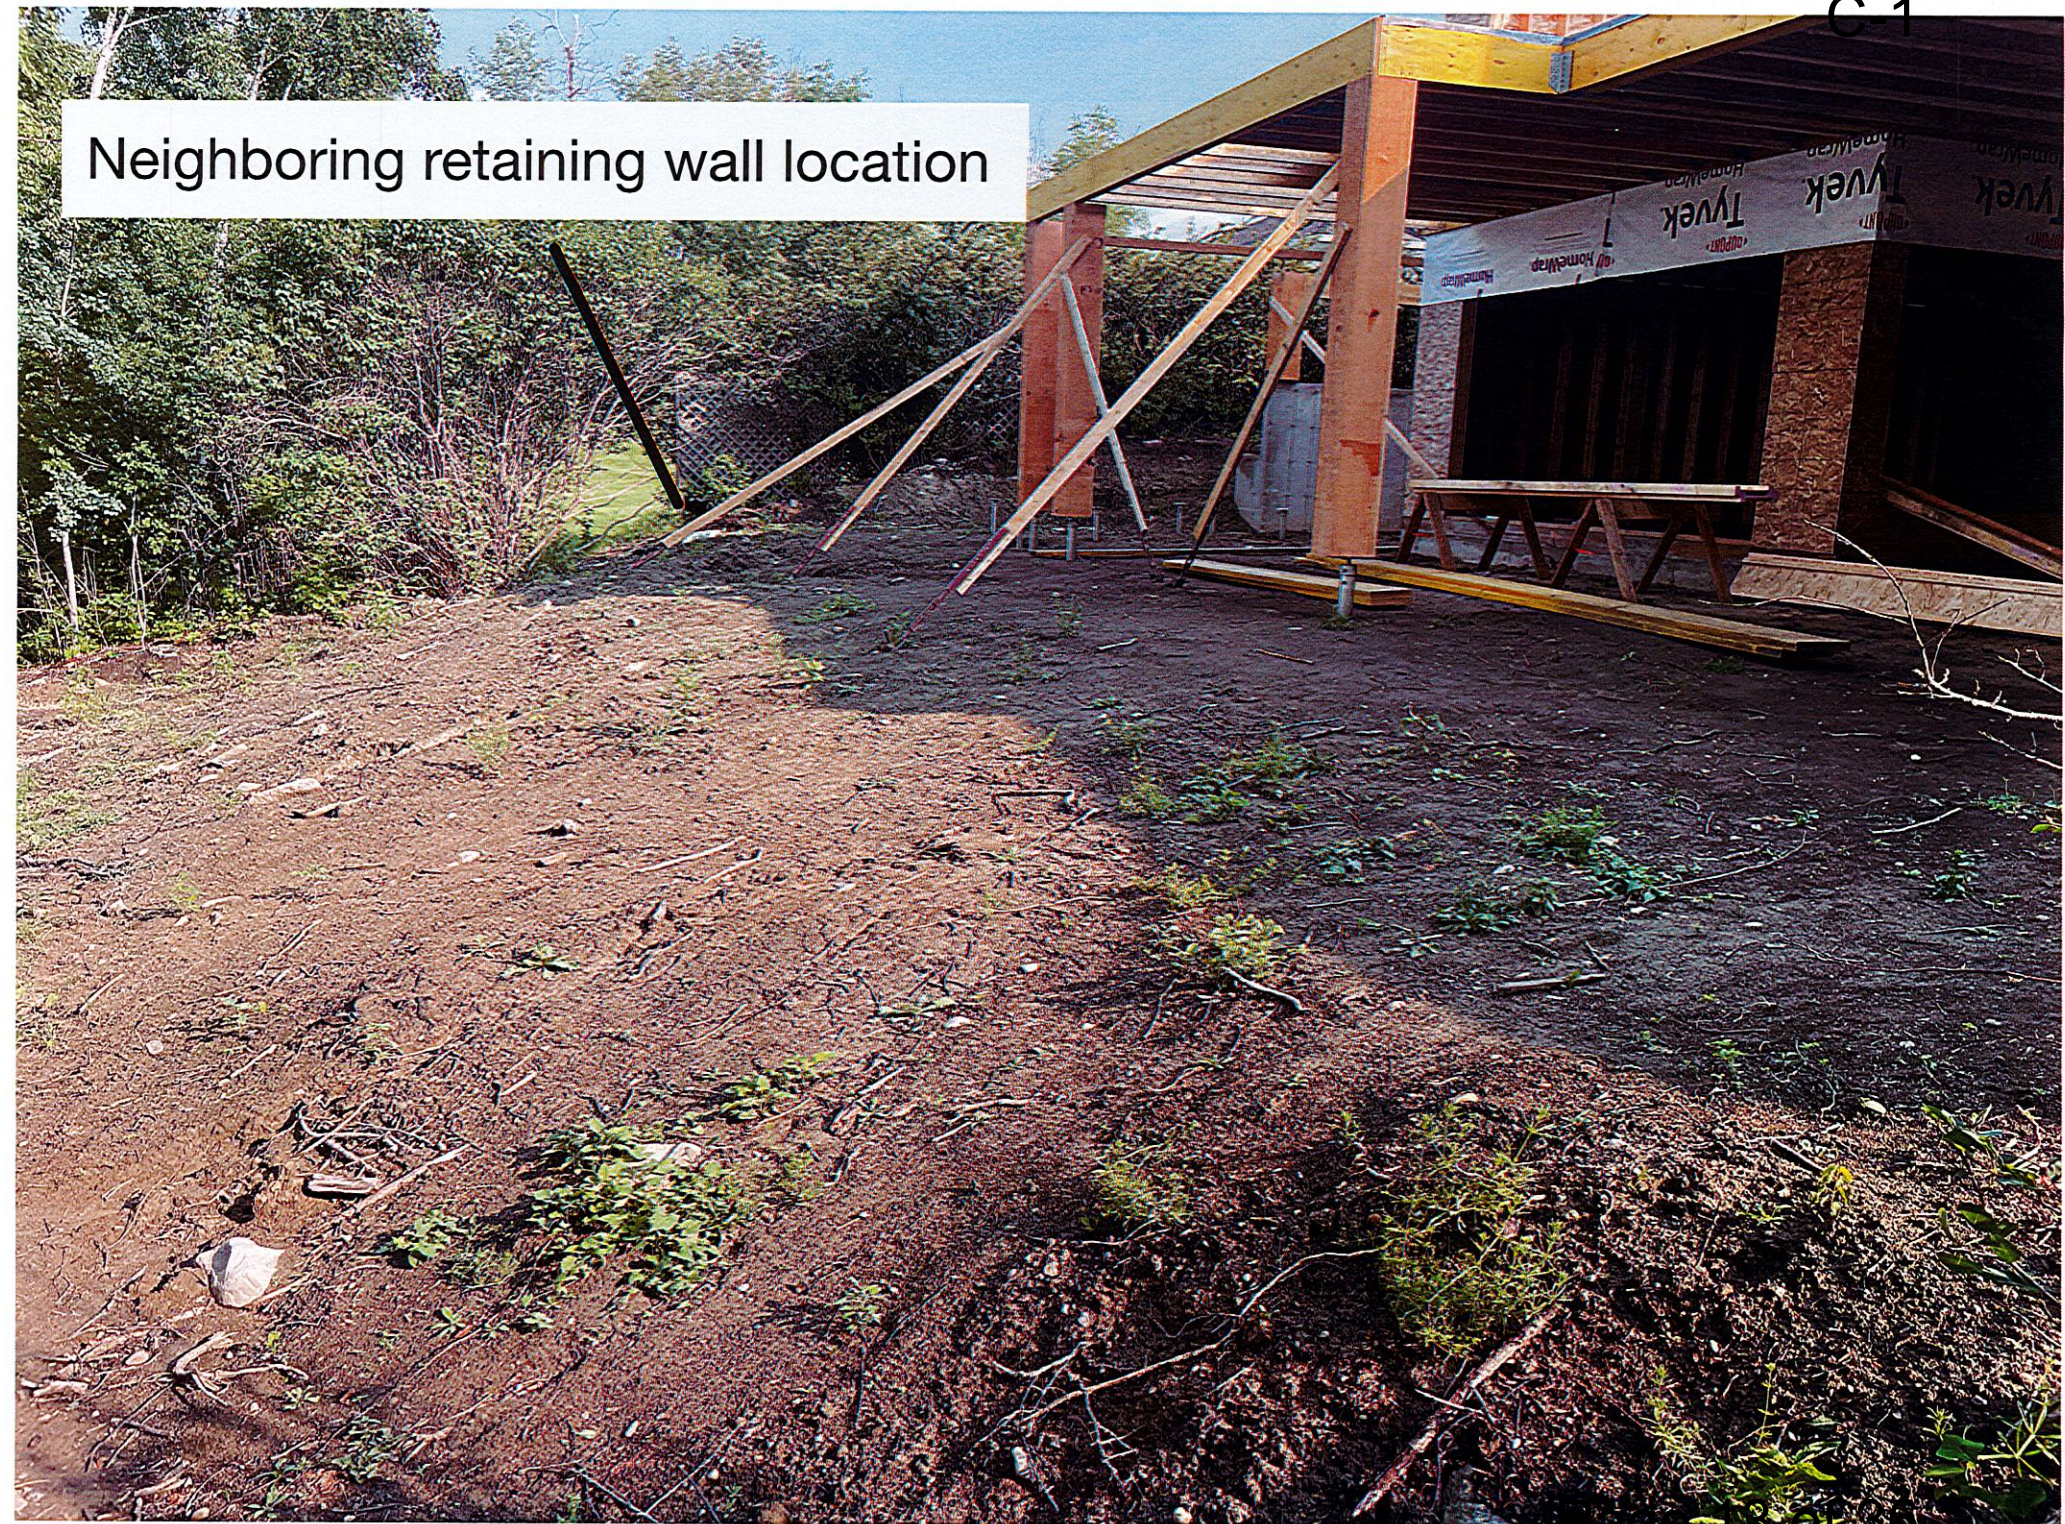
Neighbouring retaining wall height
to be matched with upper wall

In addition to replacing the existing walls, an additional wall is desired to accommodate the grade of the yard and transition elevation differences to the neighboring lot. This upper wall will not be on the escarpment and will be constructed using the same material as the lower walls.

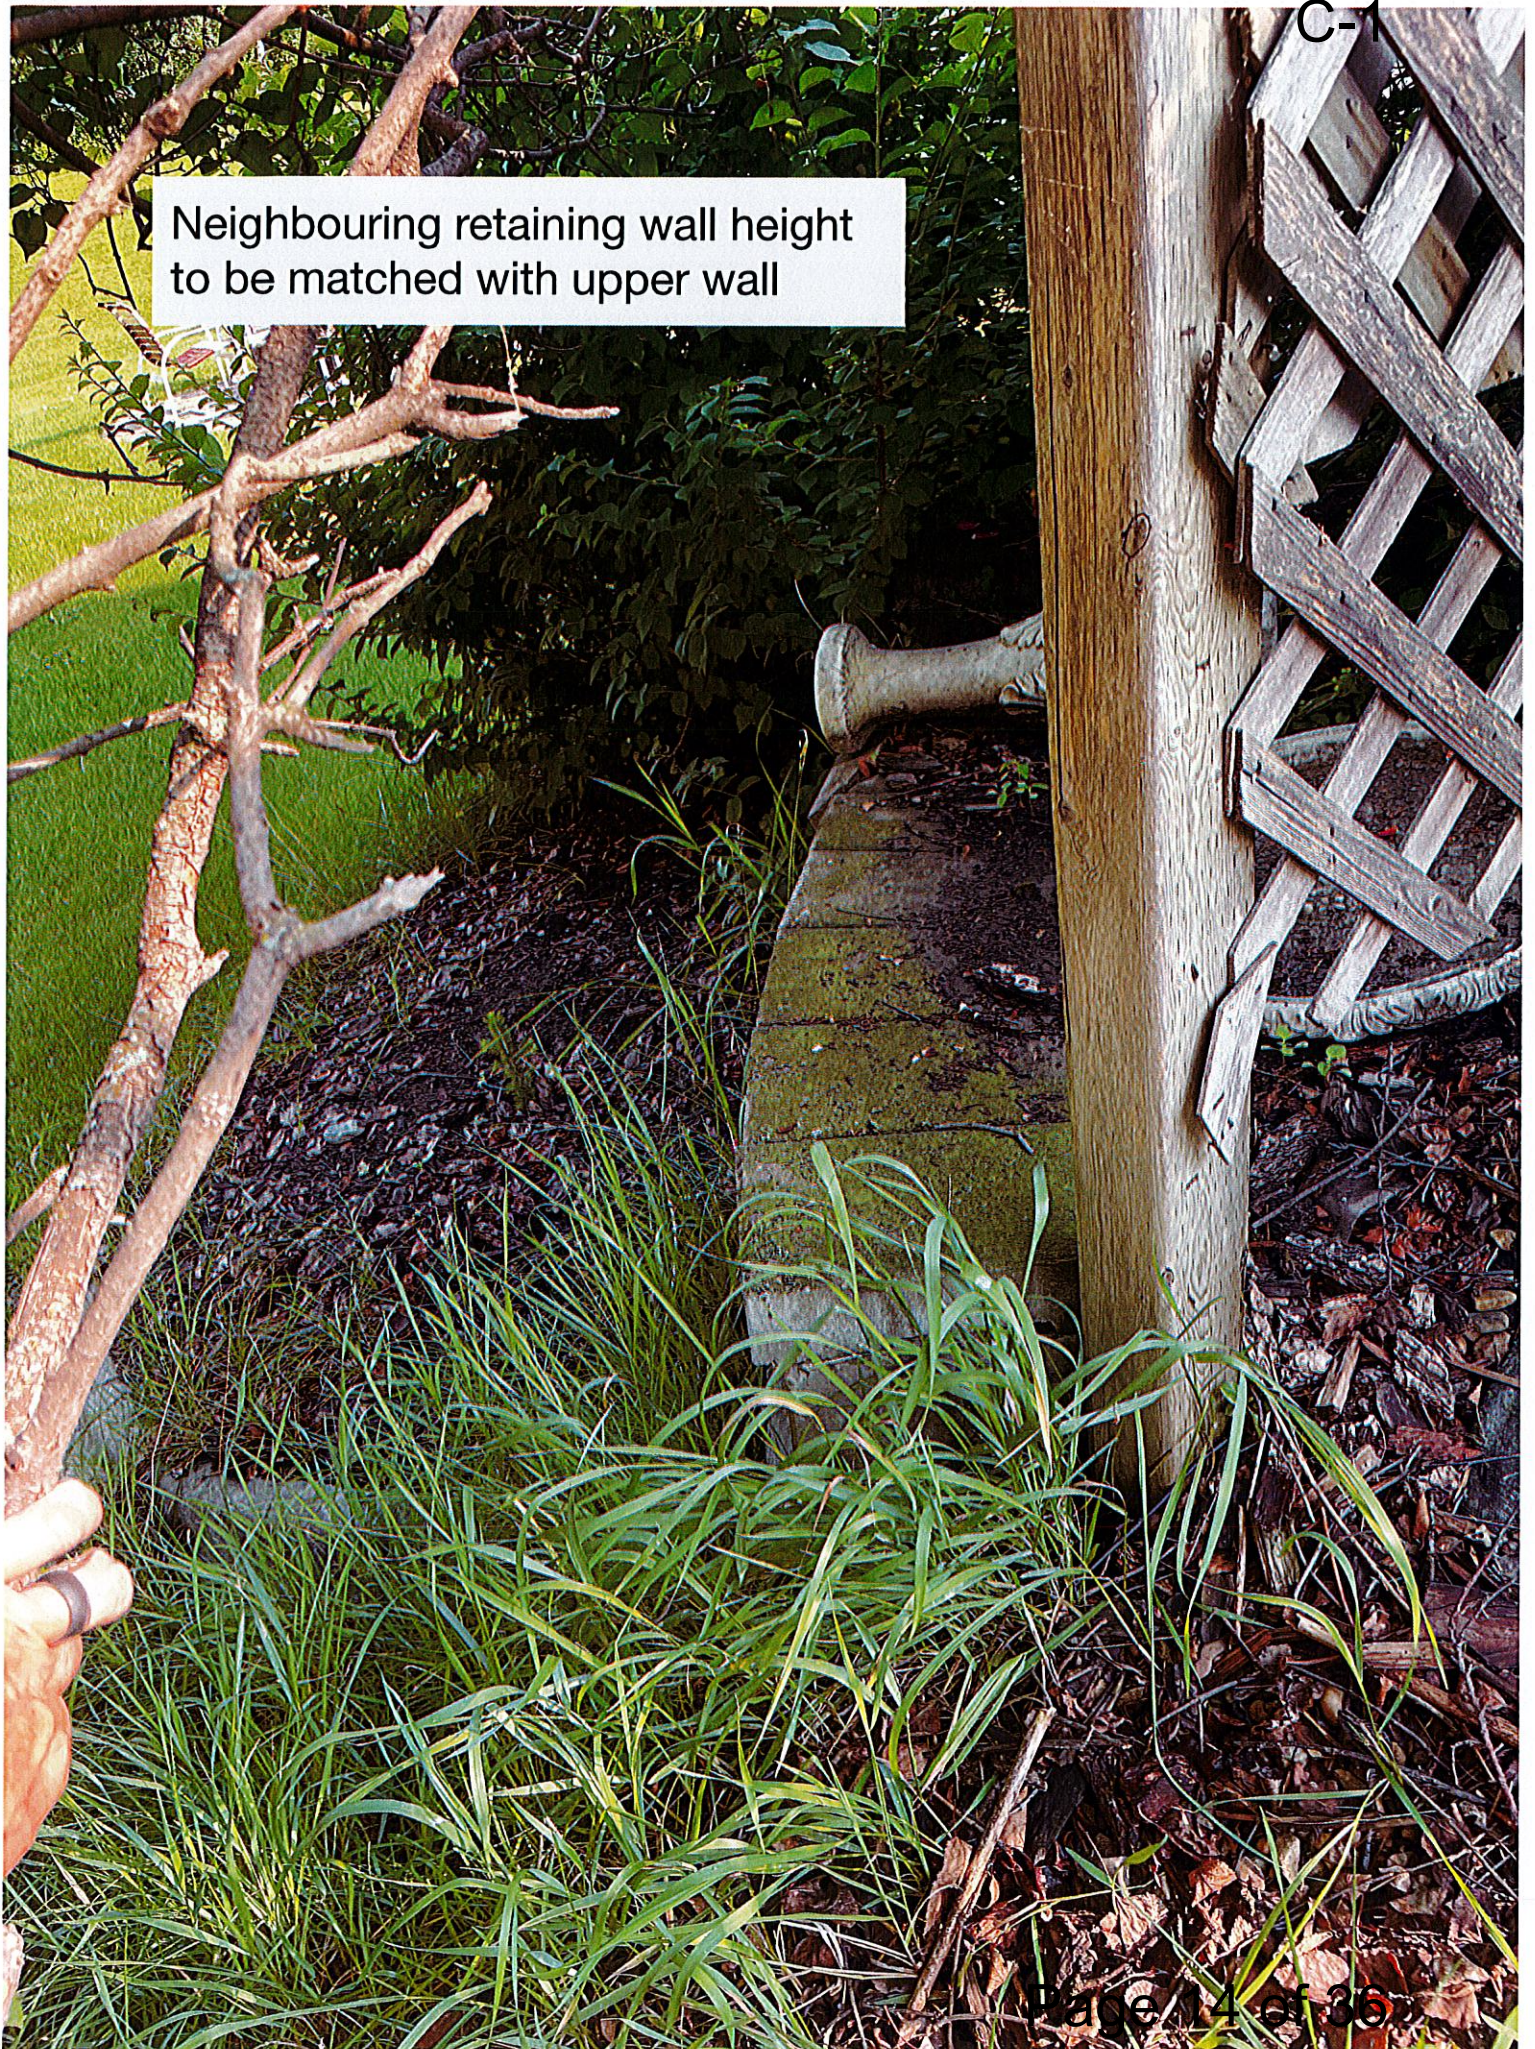
upper retaining wall to be installed to reduce slope for maintenance and to mitigate erosion

Precast stairs to be used

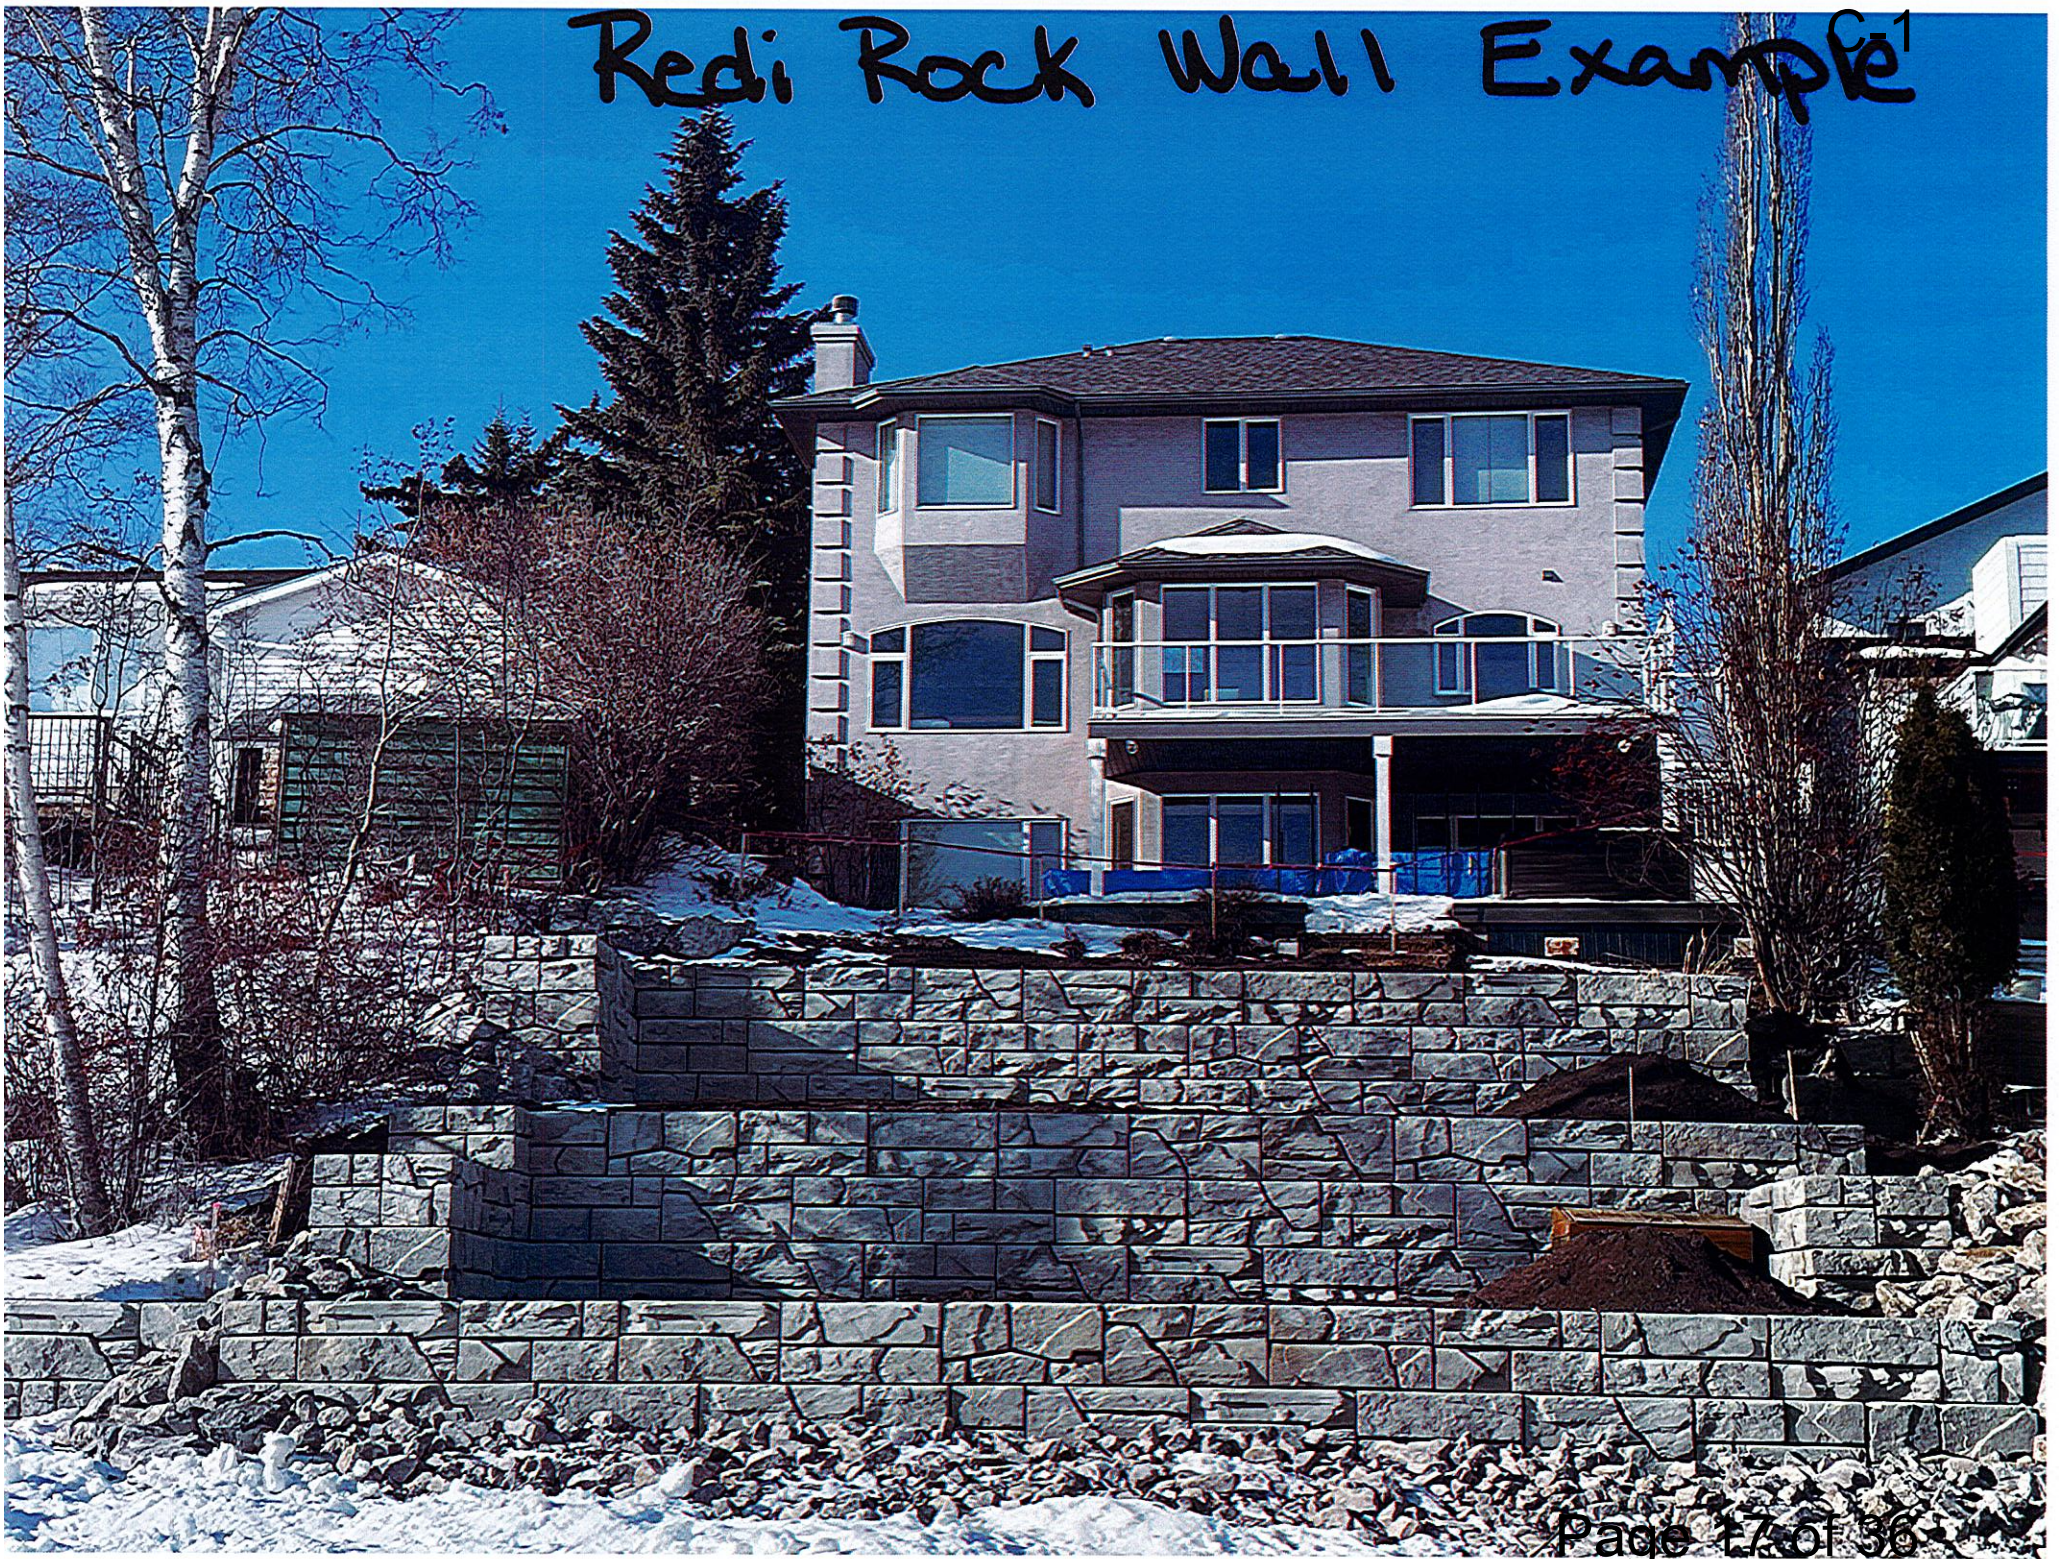
Redi Rock Wall Example¹

Verti Block concrete blocks are proposed to be used to construct the walls. This product has been approved for many other walls in the neighborhood and will be keeping a consistent appearance with these other properties. These proposed walls have been reviewed by Phil Kwong of Smith Dow and Associates, and a report has been prepared supporting the concept. If approved, Smith Dow and Associates will provide engineered drawings for the construction of the walls and complete construction inspections.

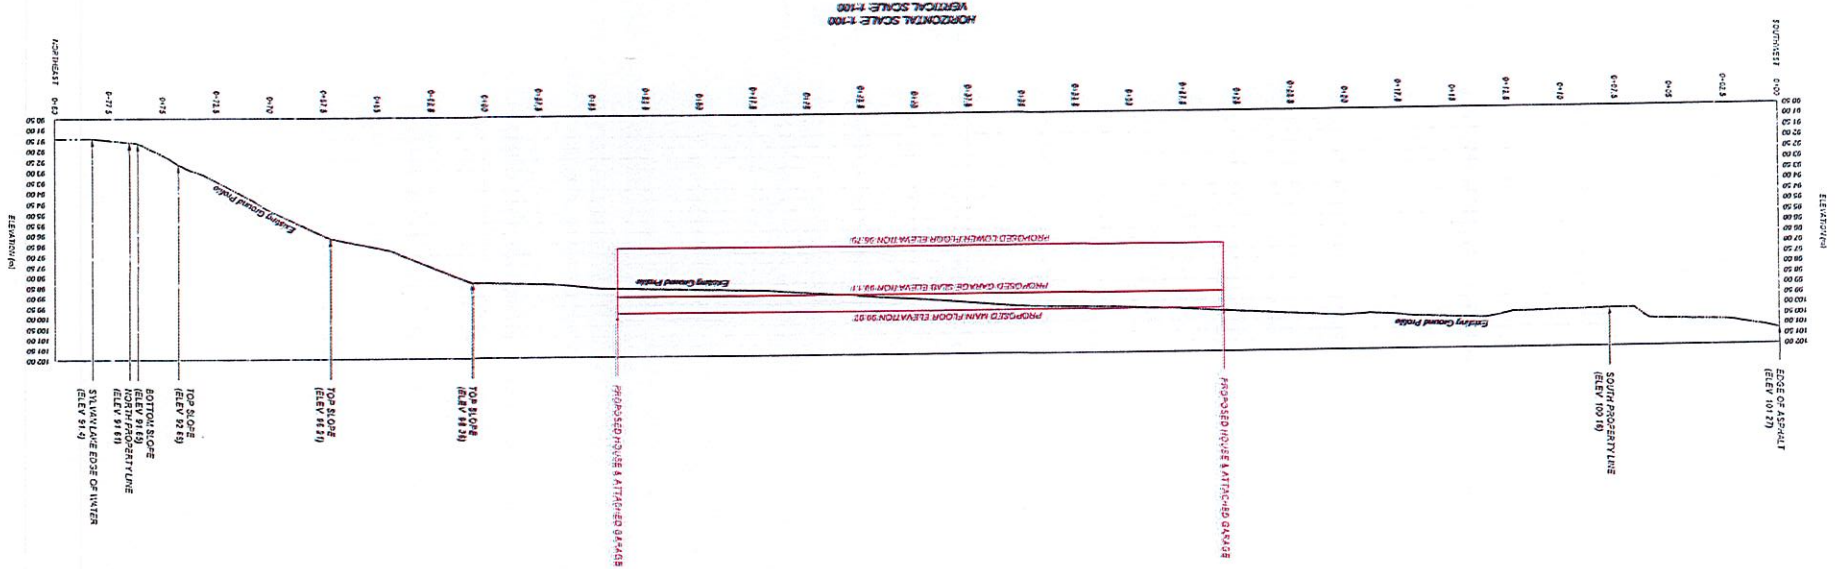
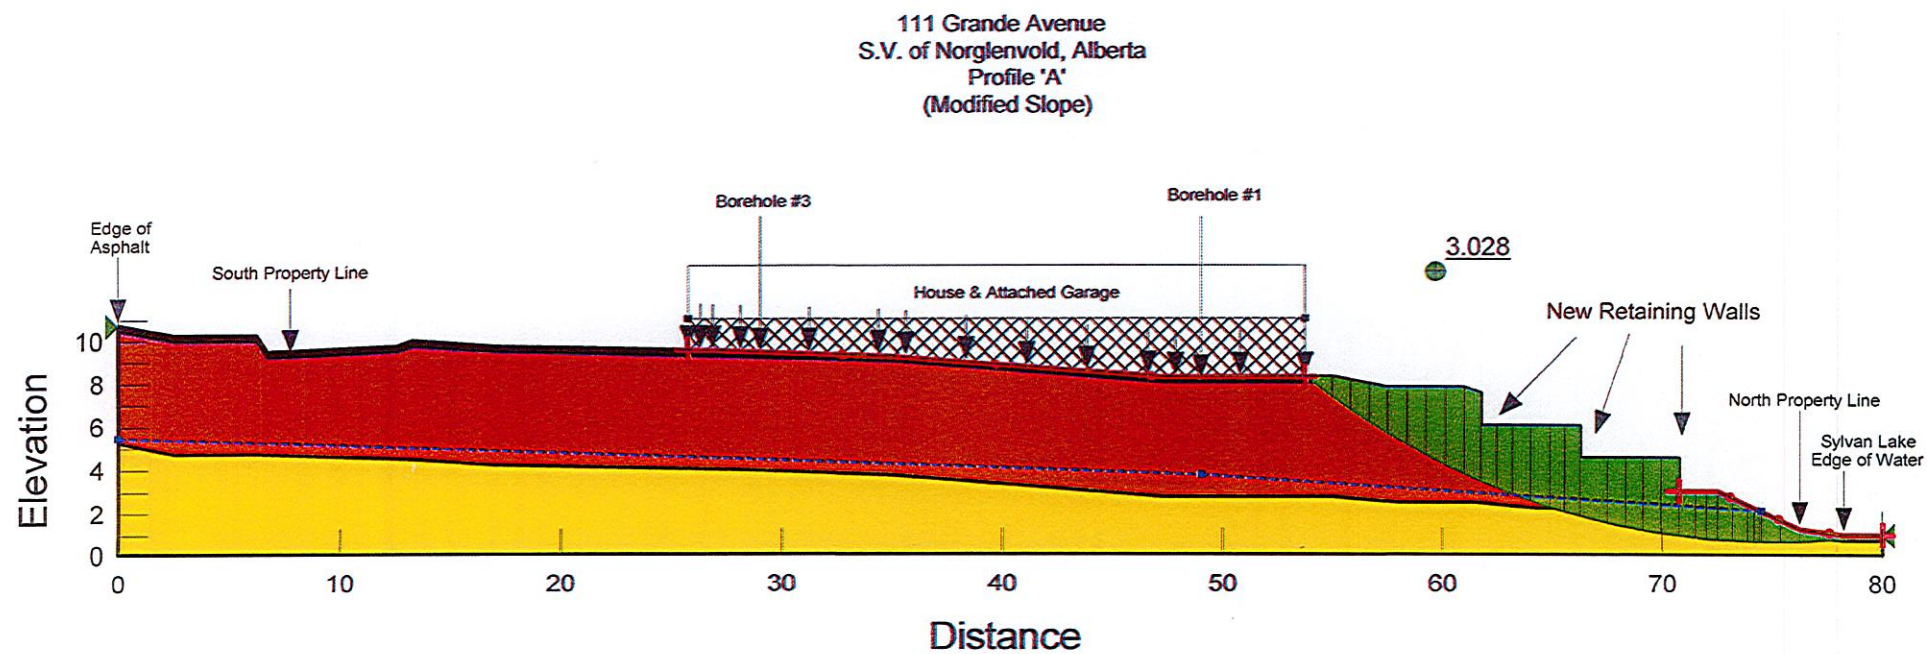
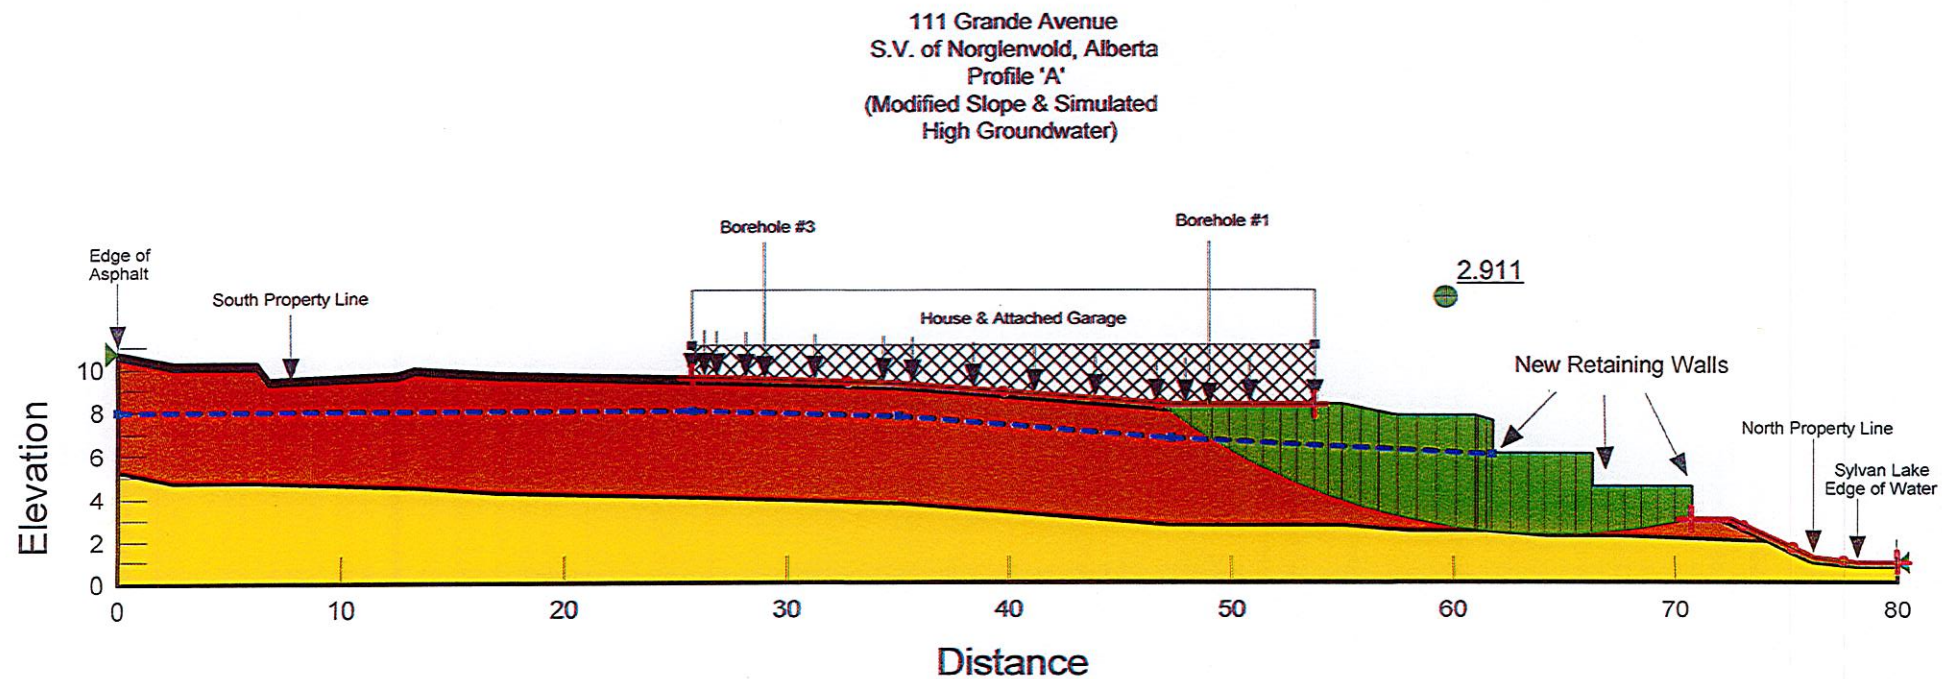
PROFILE 'A'

- a) Under “normal” groundwater and slope conditions while using the new slope cross-sectional profile ‘A’ in combination with Lakeview Contracting’s retaining wall structure.

This first stage of the slope stability analysis confirms a long-term factor of safety (F.S.) of 3.028 for under normal groundwater conditions as mentioned above. This means the existing slope with the new residence and the new three - 5 foot retaining walls are deemed stable. The F.S. of 3.028 of the existing cross-sectional slope profile exceeds the minimum required FS of 1.5.

The second stage of the slope stability assessment for the simulated high ground water tables revealed a long-term factor of safety (FS) of 2.911 can still be achieved with these parameters for cross-sectional profile A in combination with Lakeview Contracting’s three new retaining wall structures. The F.S. of 2.911 also exceed the minimum required FS = 1.5.
