**MUNICIPAL PLANNING COMMISSION AGENDA
SUMMER VILLAGE OF NORGLNWOLD
SUMMER VILLAGES ADMINISTRATION OFFICE
JULY 9, 2021 @ 9:00 A.M.**

Summer Village of Norglenwold – Municipal Planning Commission**July 9, 2021****Agenda Item****205 Grand Avenue (Lot 13, Block 2, Plan 2203KS)****Development Permit Application****Background:**

GEOTECHNICAL SLOPE ASSESSMENT

PARKLAND GEOTECHNICAL CONSULTING LTD.
RED DEER, ALBERTA

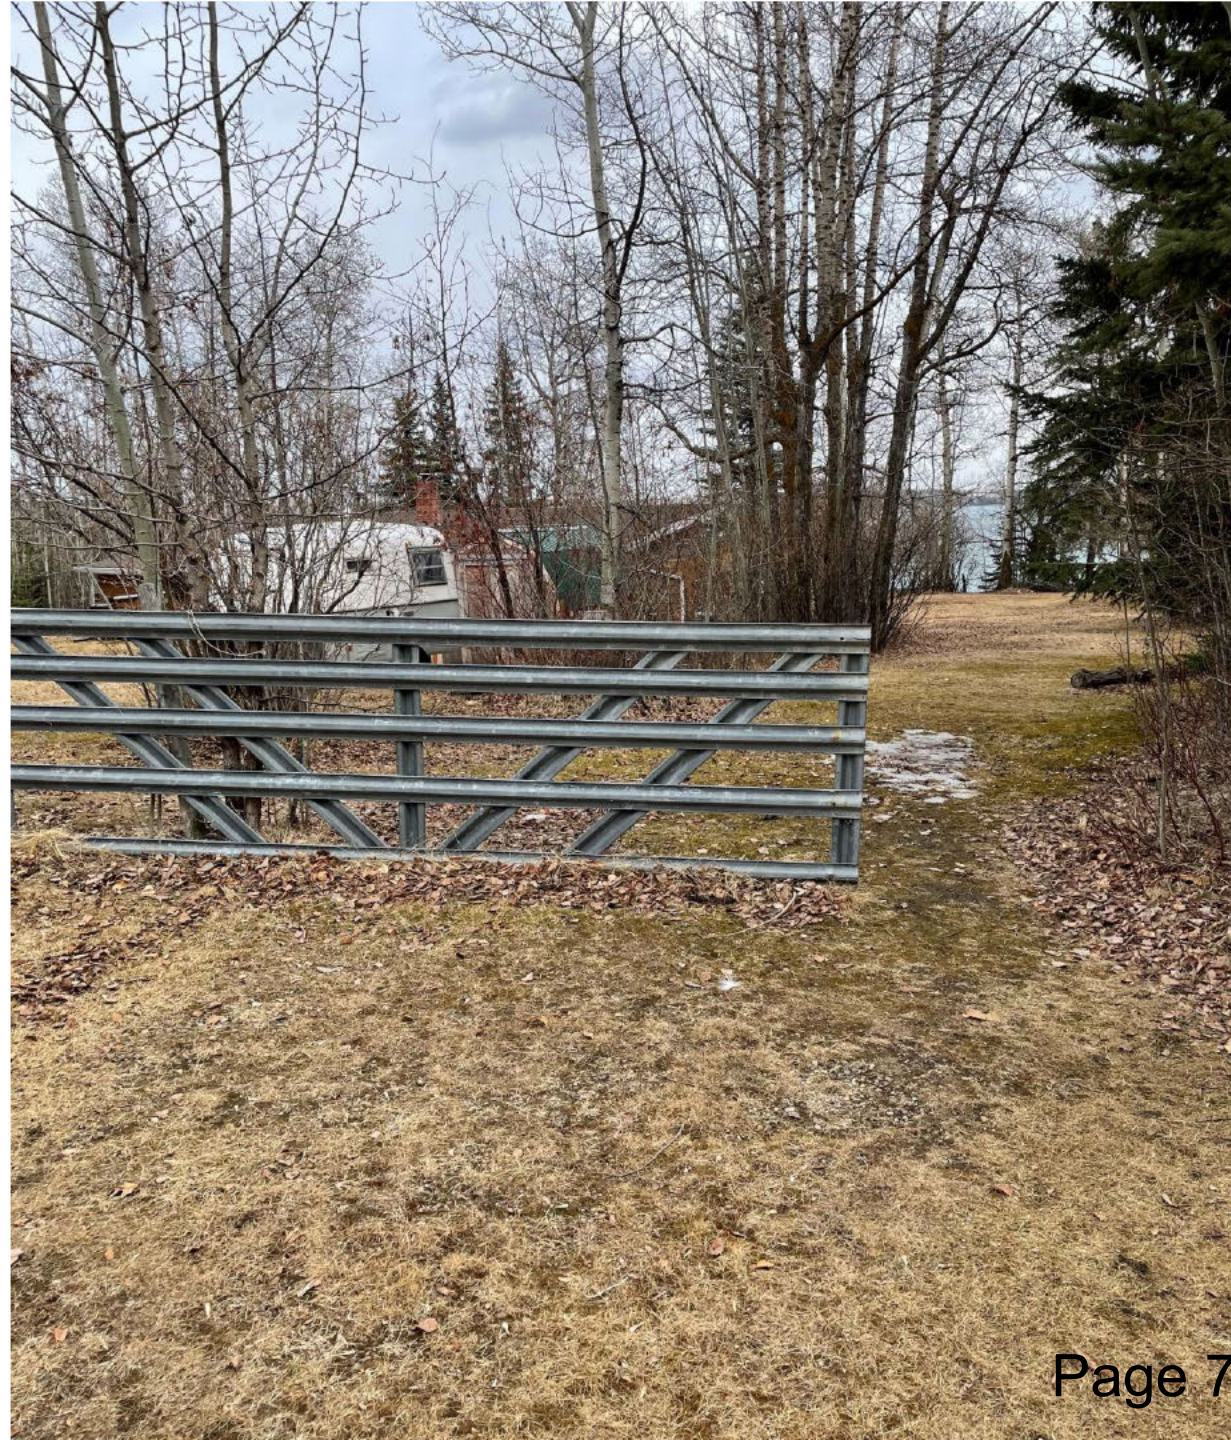
View from
the road to
the lake

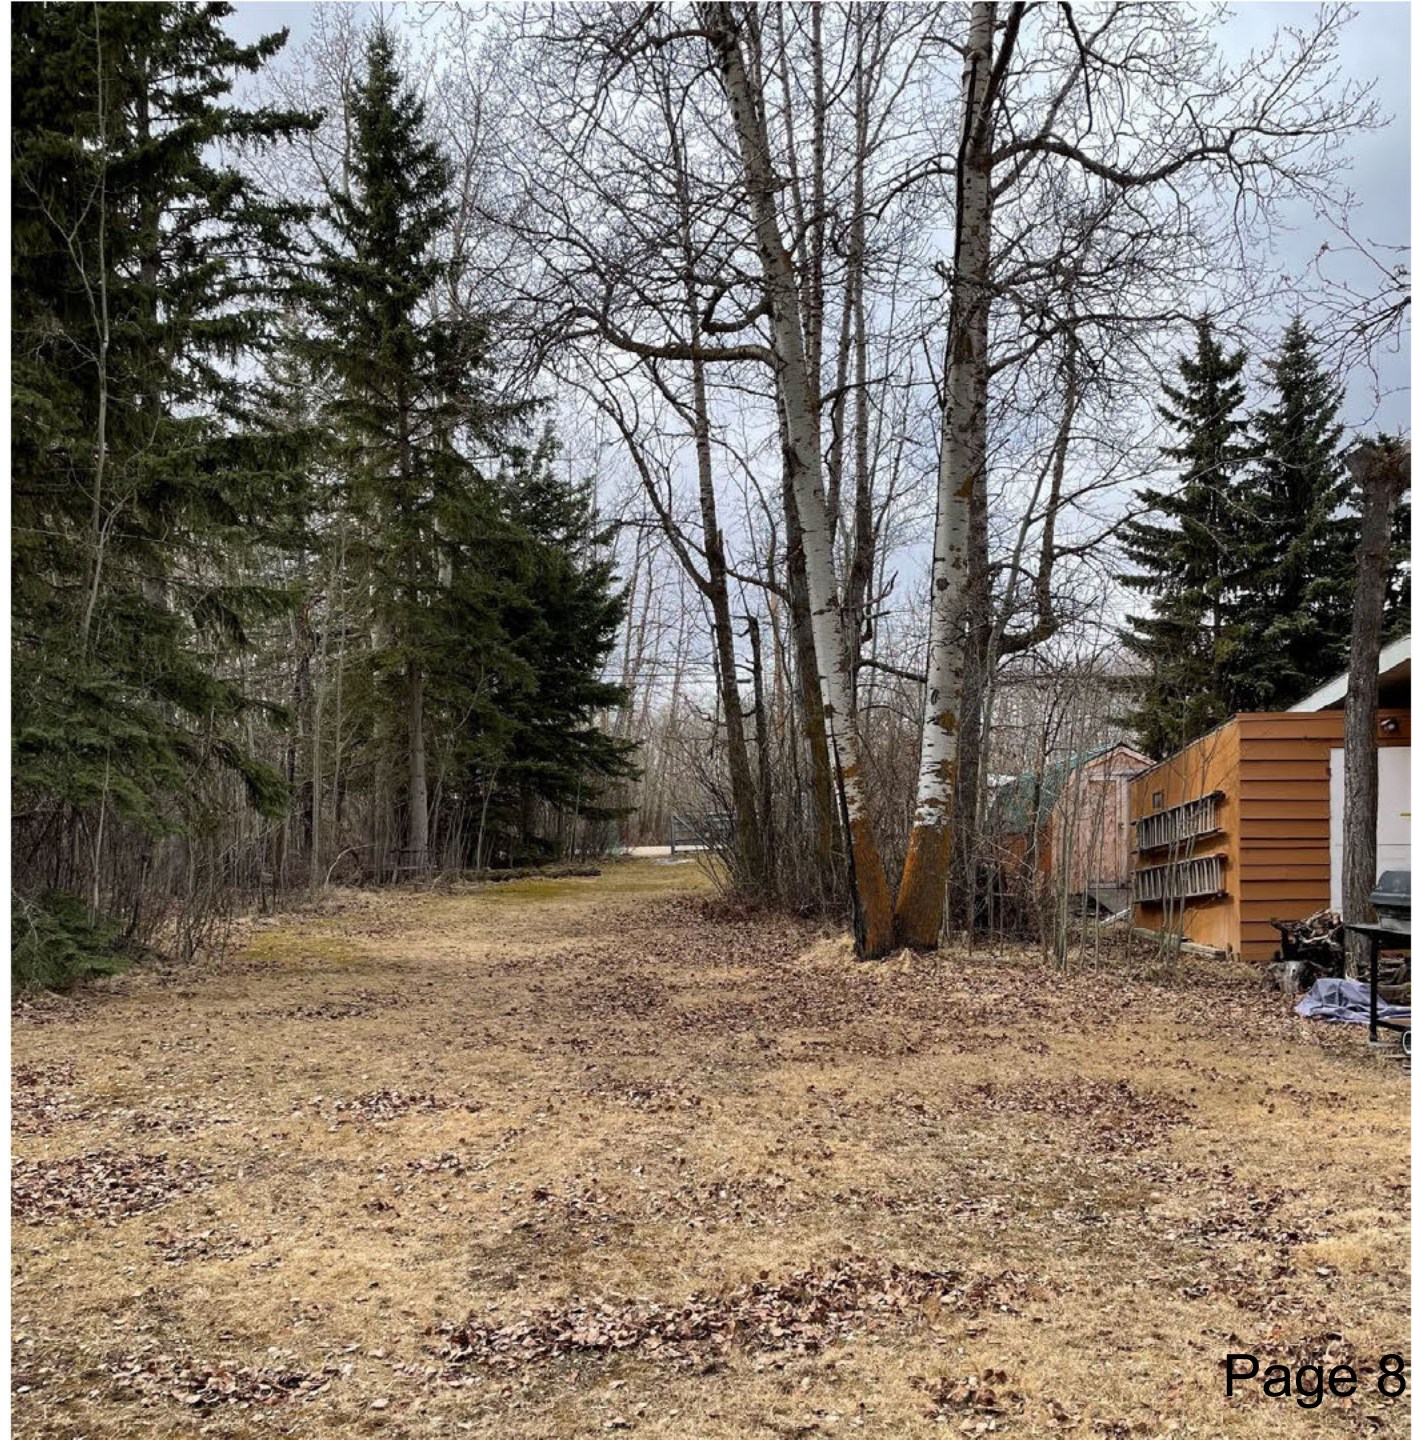
View from
the bank back
to the road

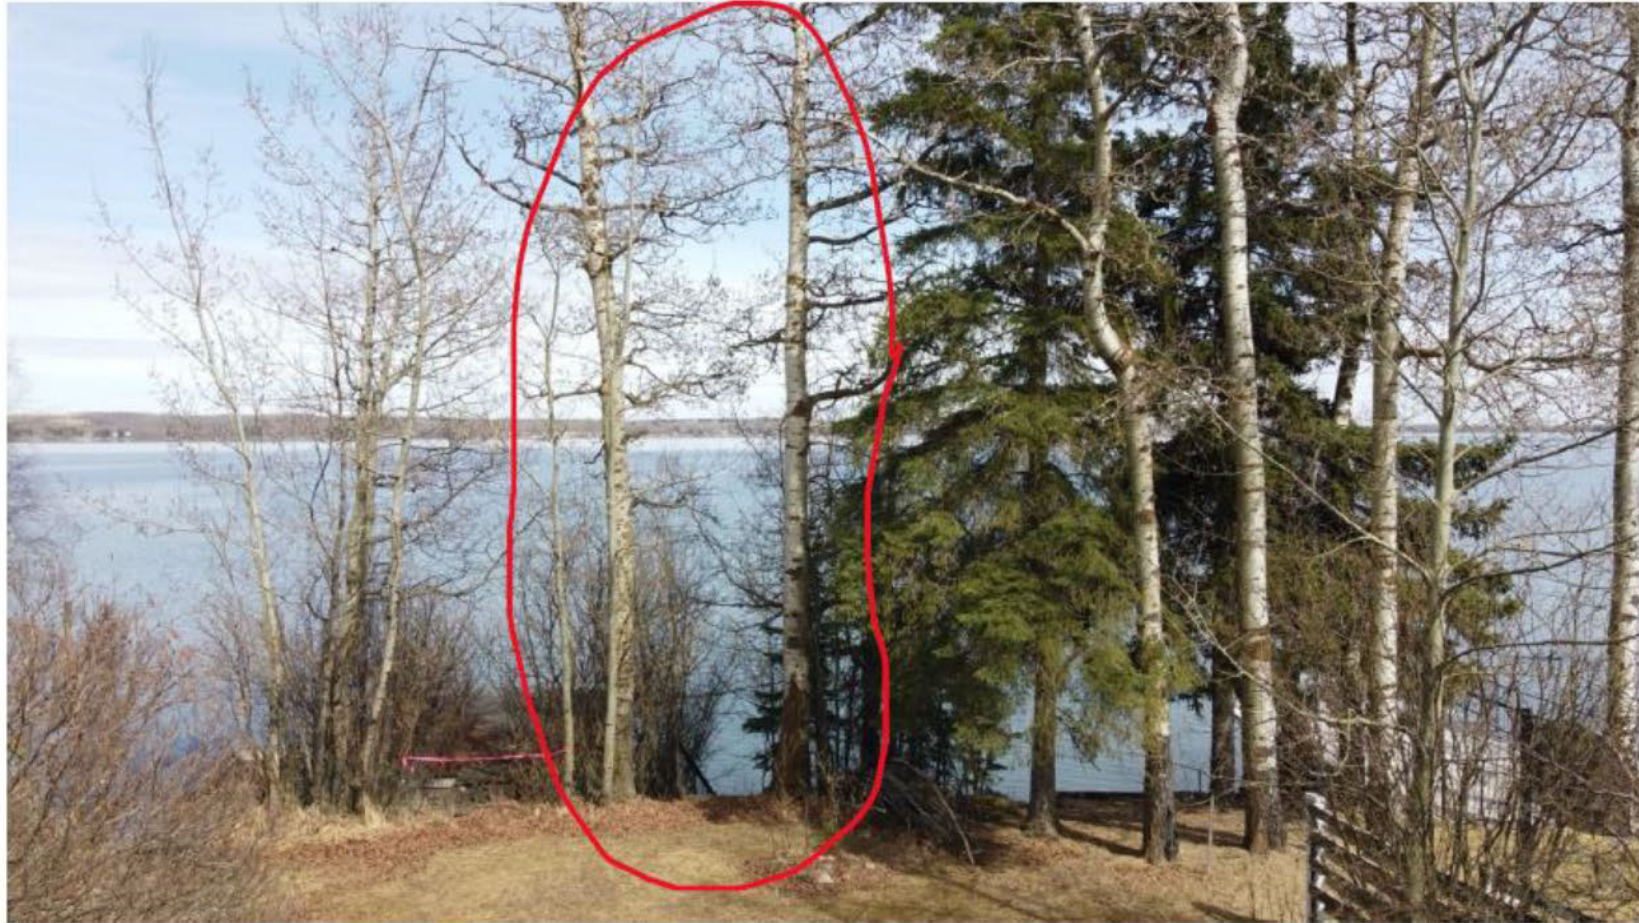
The poplar trees circled in red above are both past their best before date as they have a substantial amount of deadwood.

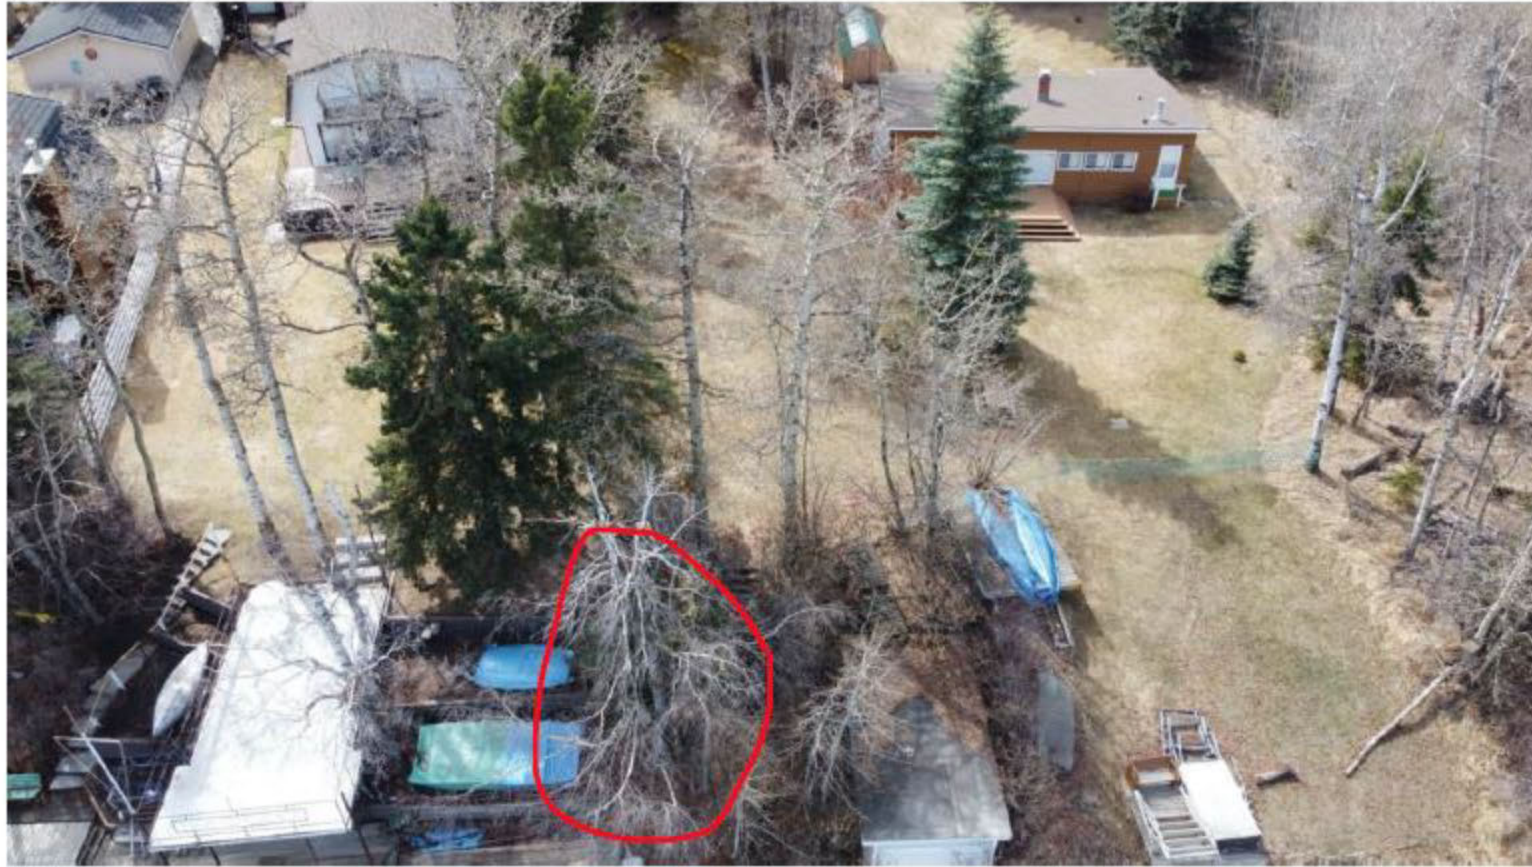
The birch circled in red above is dead as it had a metal wire wrapped around its trunk which girdled it (see picture below).

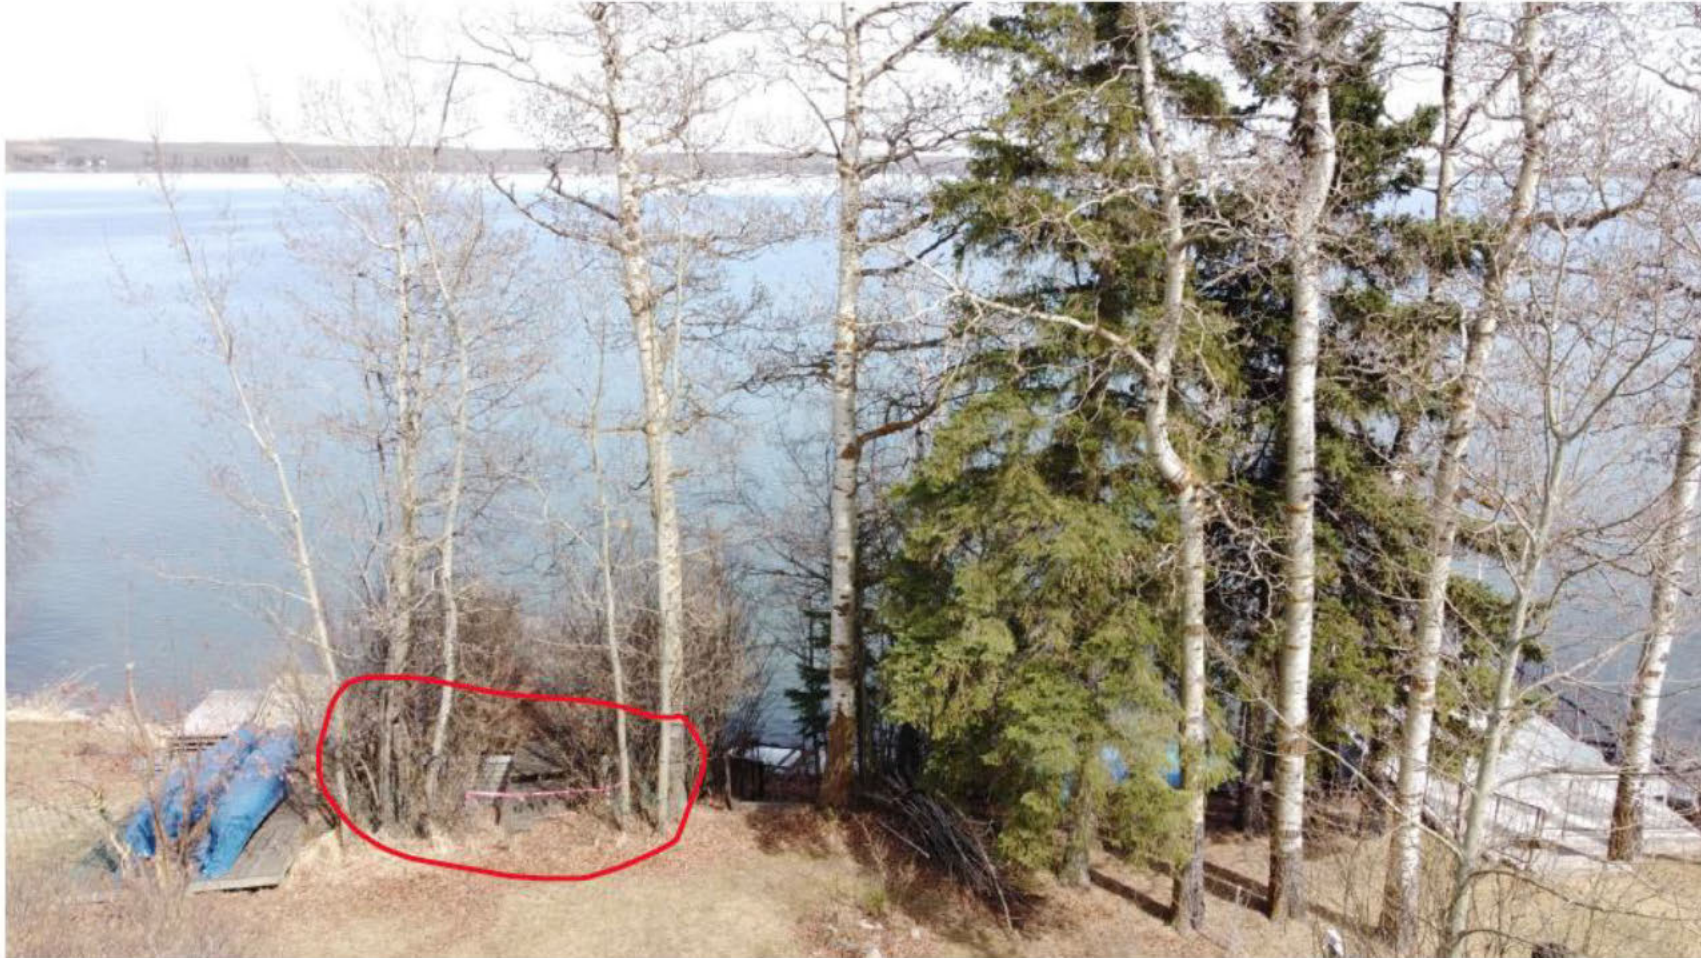
The majority of vegetation growing to the left of the staircase are growing through fencing. It is only a matter of time before these trees and shrubs die as a result of girdling from the fence (see close up pictures below).

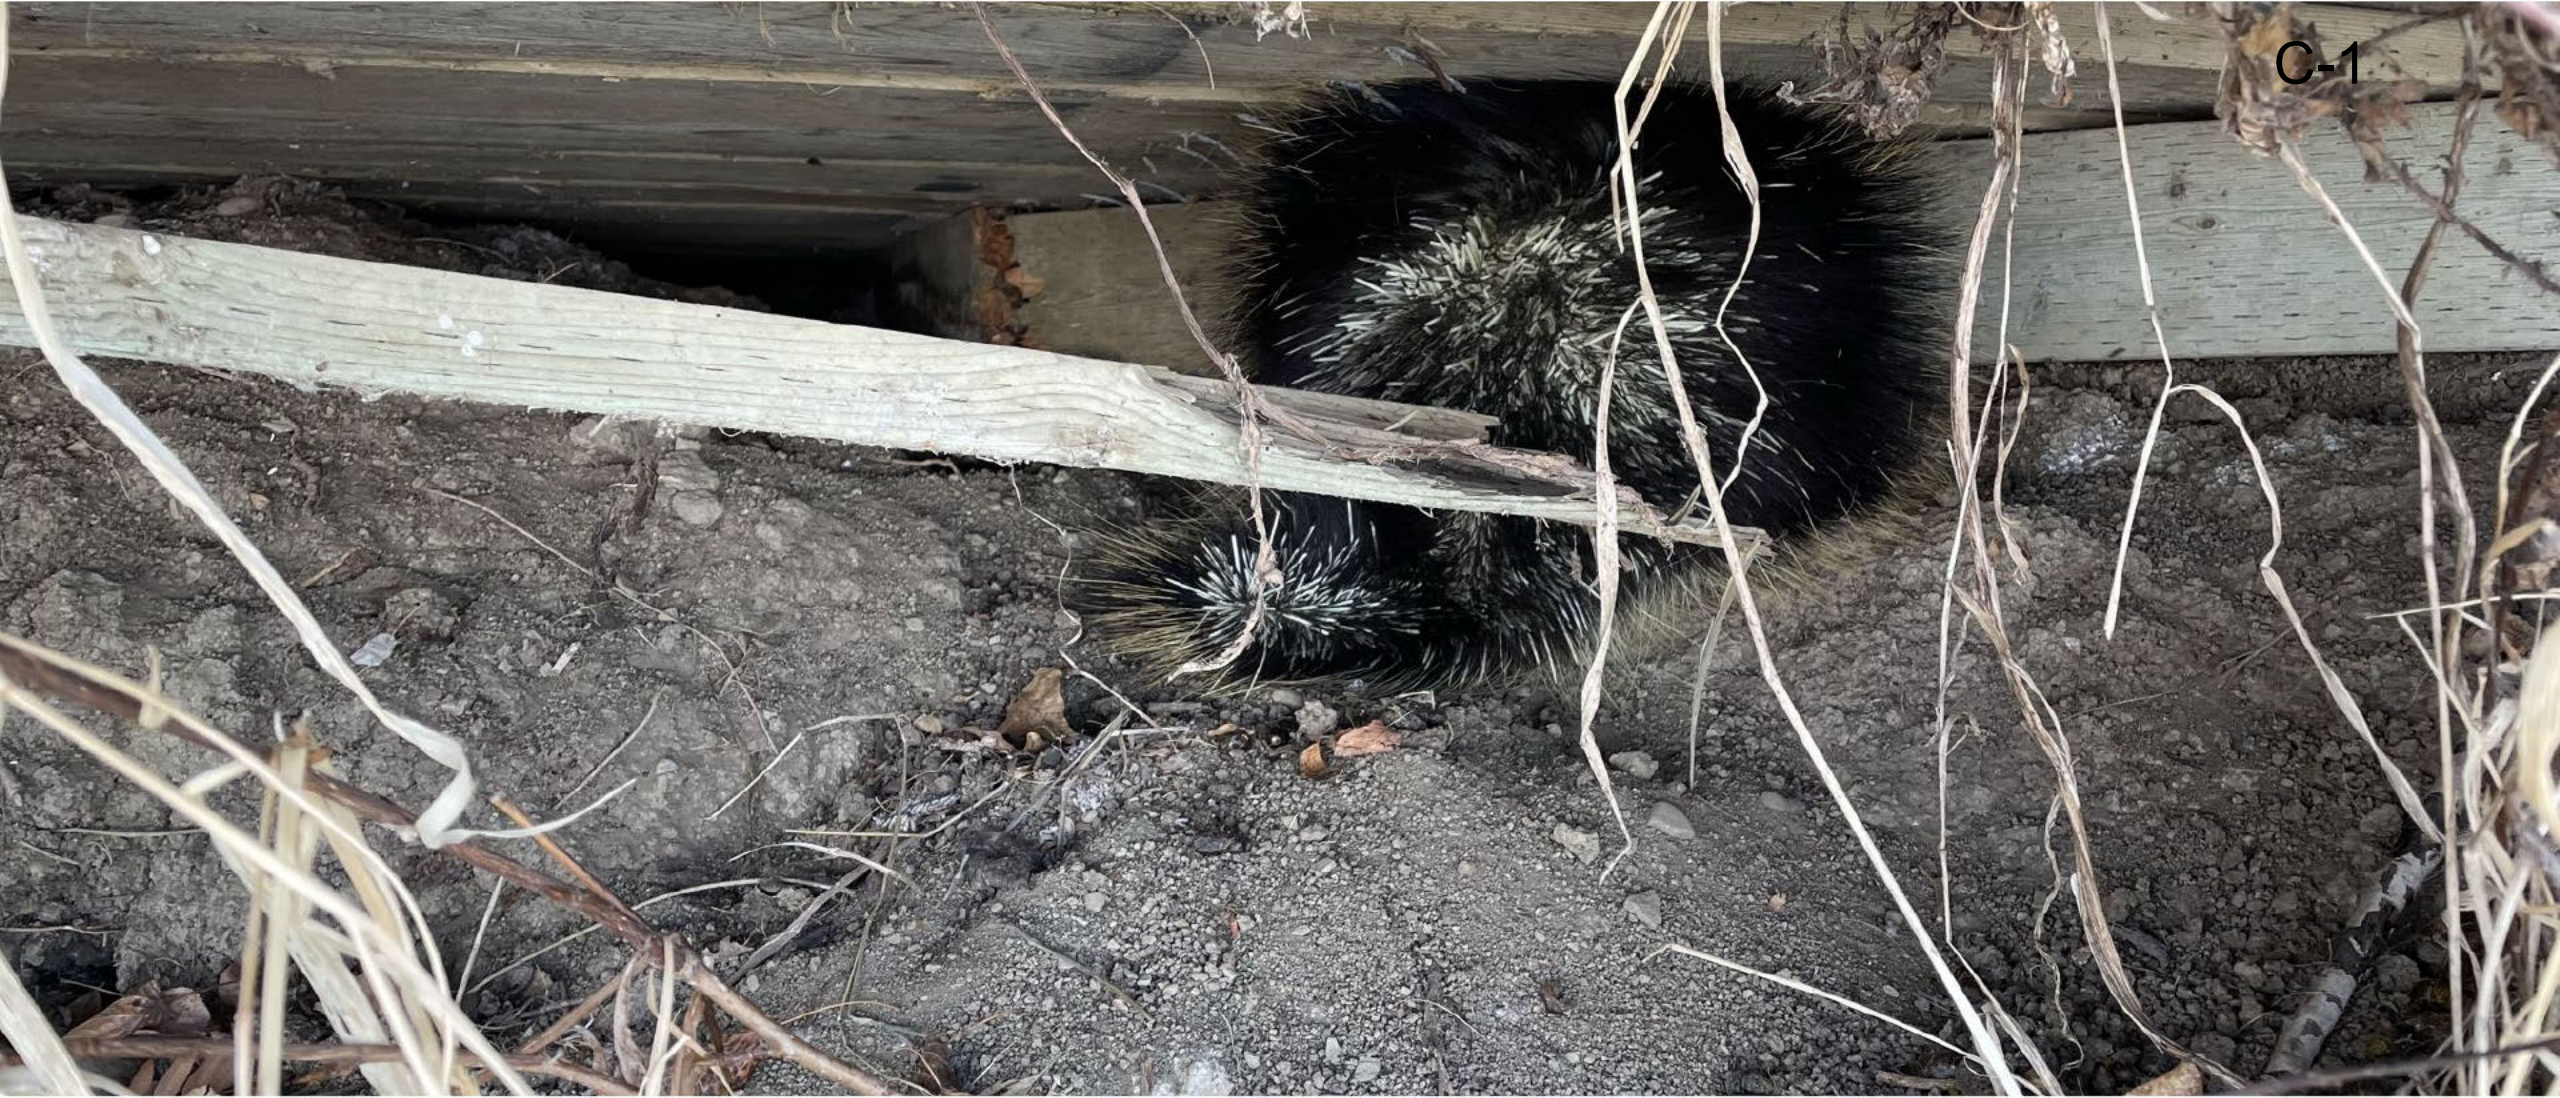
This is the foundation structure of the boathouse. The center beam is broken off and appears to be rotten. Great home for the porcupine.

Behind the boathouse there was never a proper retaining wall. This is now a danger for my grandkids with a 10inch space that is over 3 feet deep and caving in.

The foundation of the boathouse is damaged and the main beams appear to be rotten. The center beam is broken off. In order to carry out the repair of the foundation we intend to remove the roof (which needs resheeting) and take the walls down.

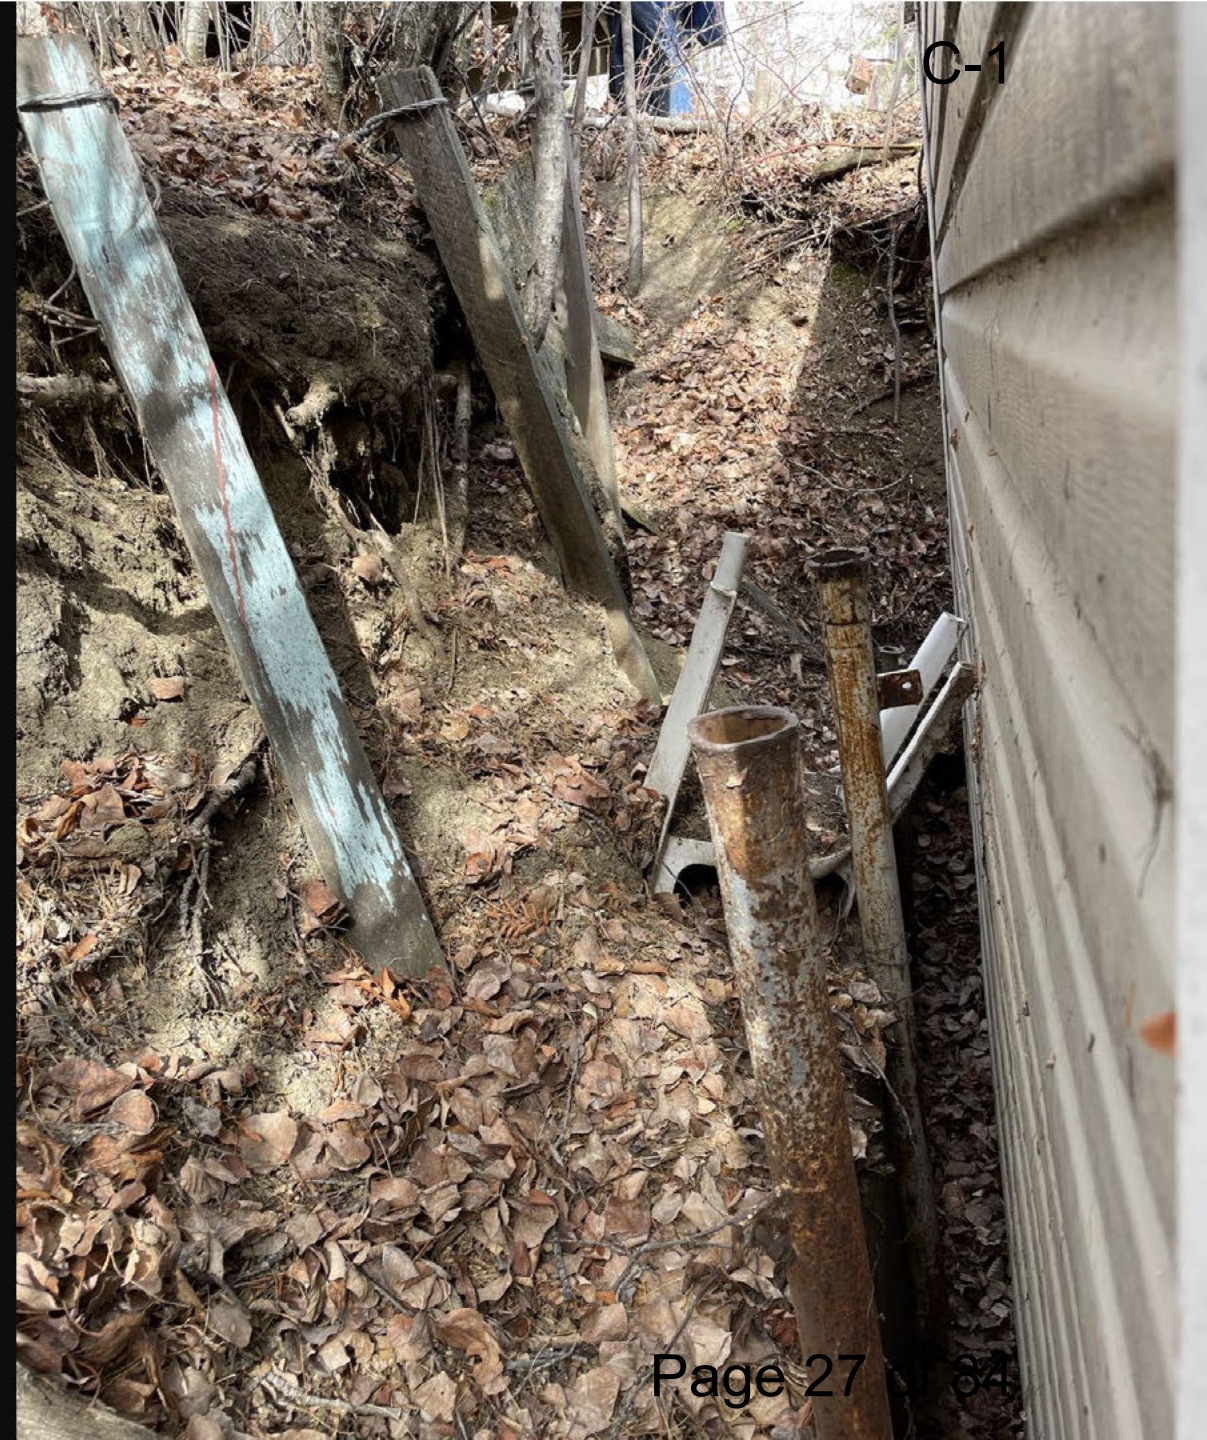
The top of the boathouse was once used for a patio. I plan to add a railing and safe walkway to utilize this and create less impact on the slope area.

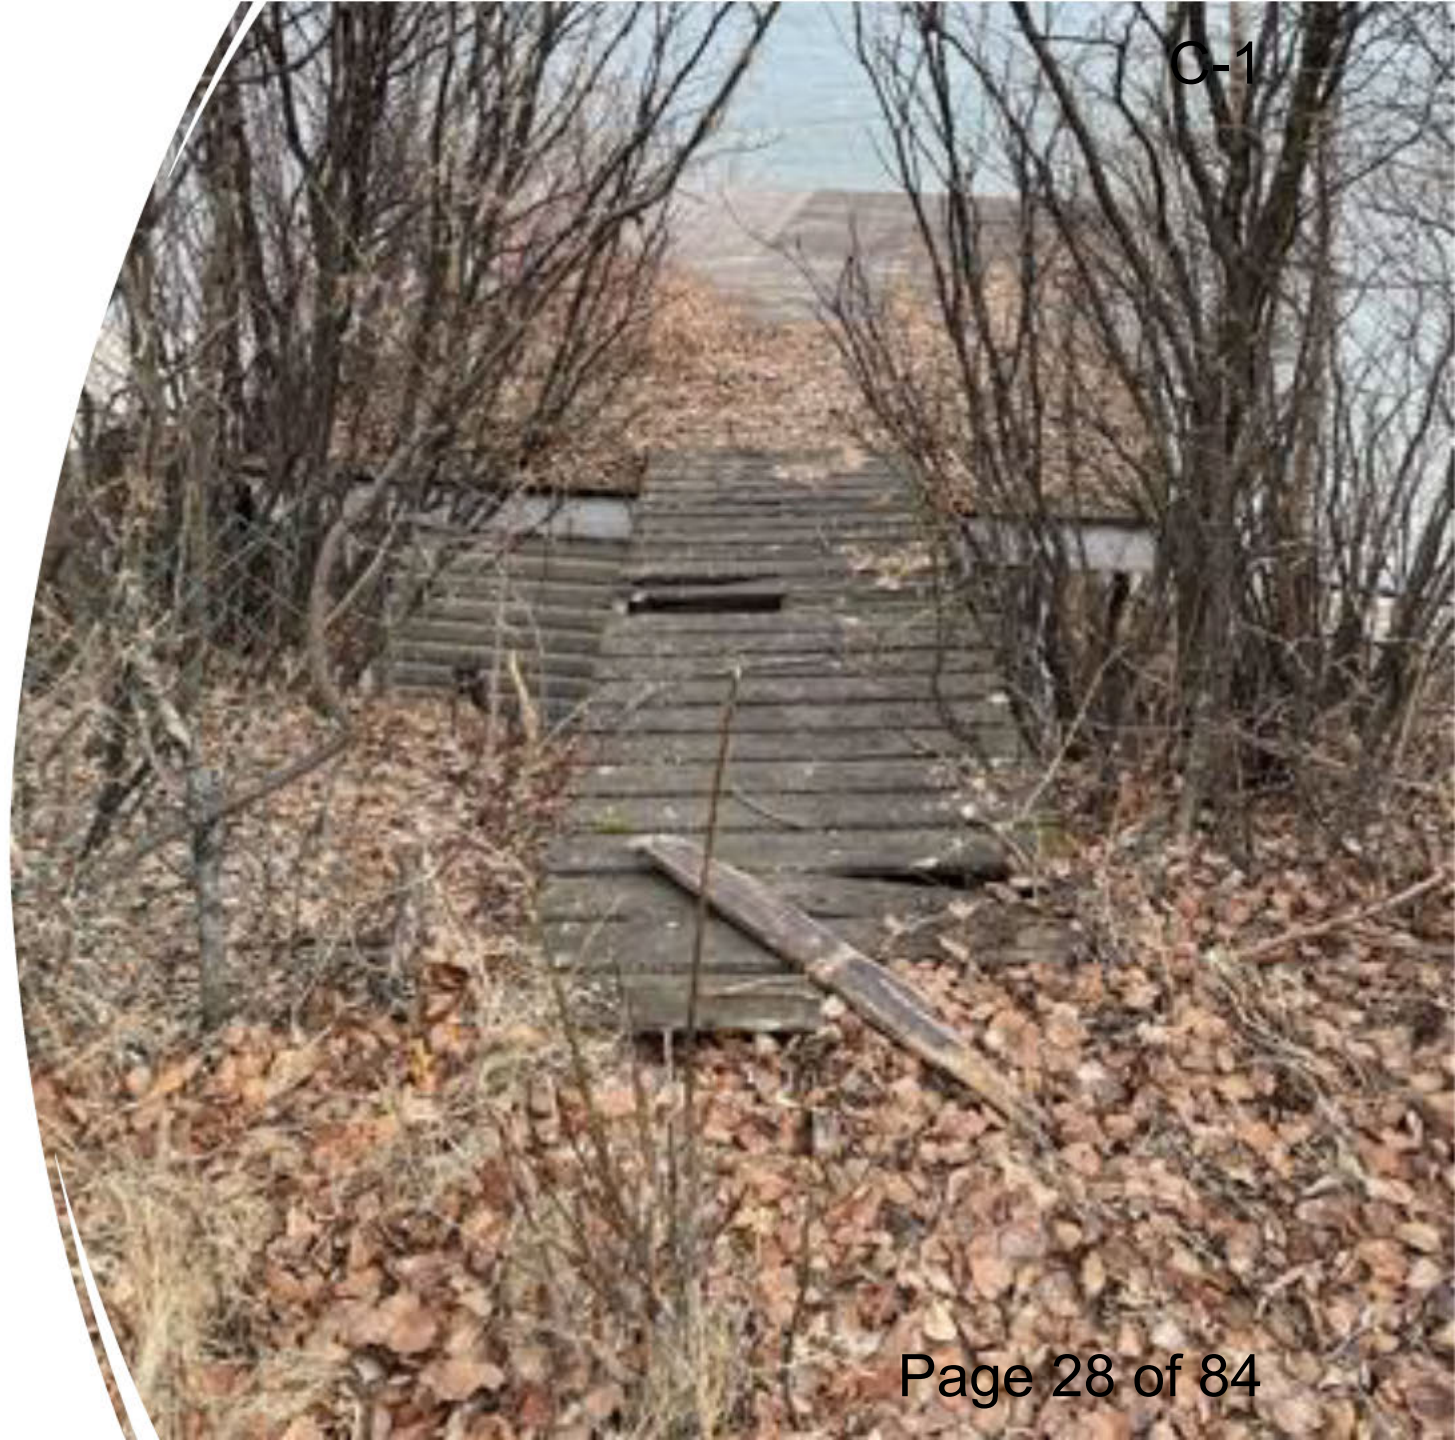
The lot to the north has been cleared and sloped at about a 4-1 slope.

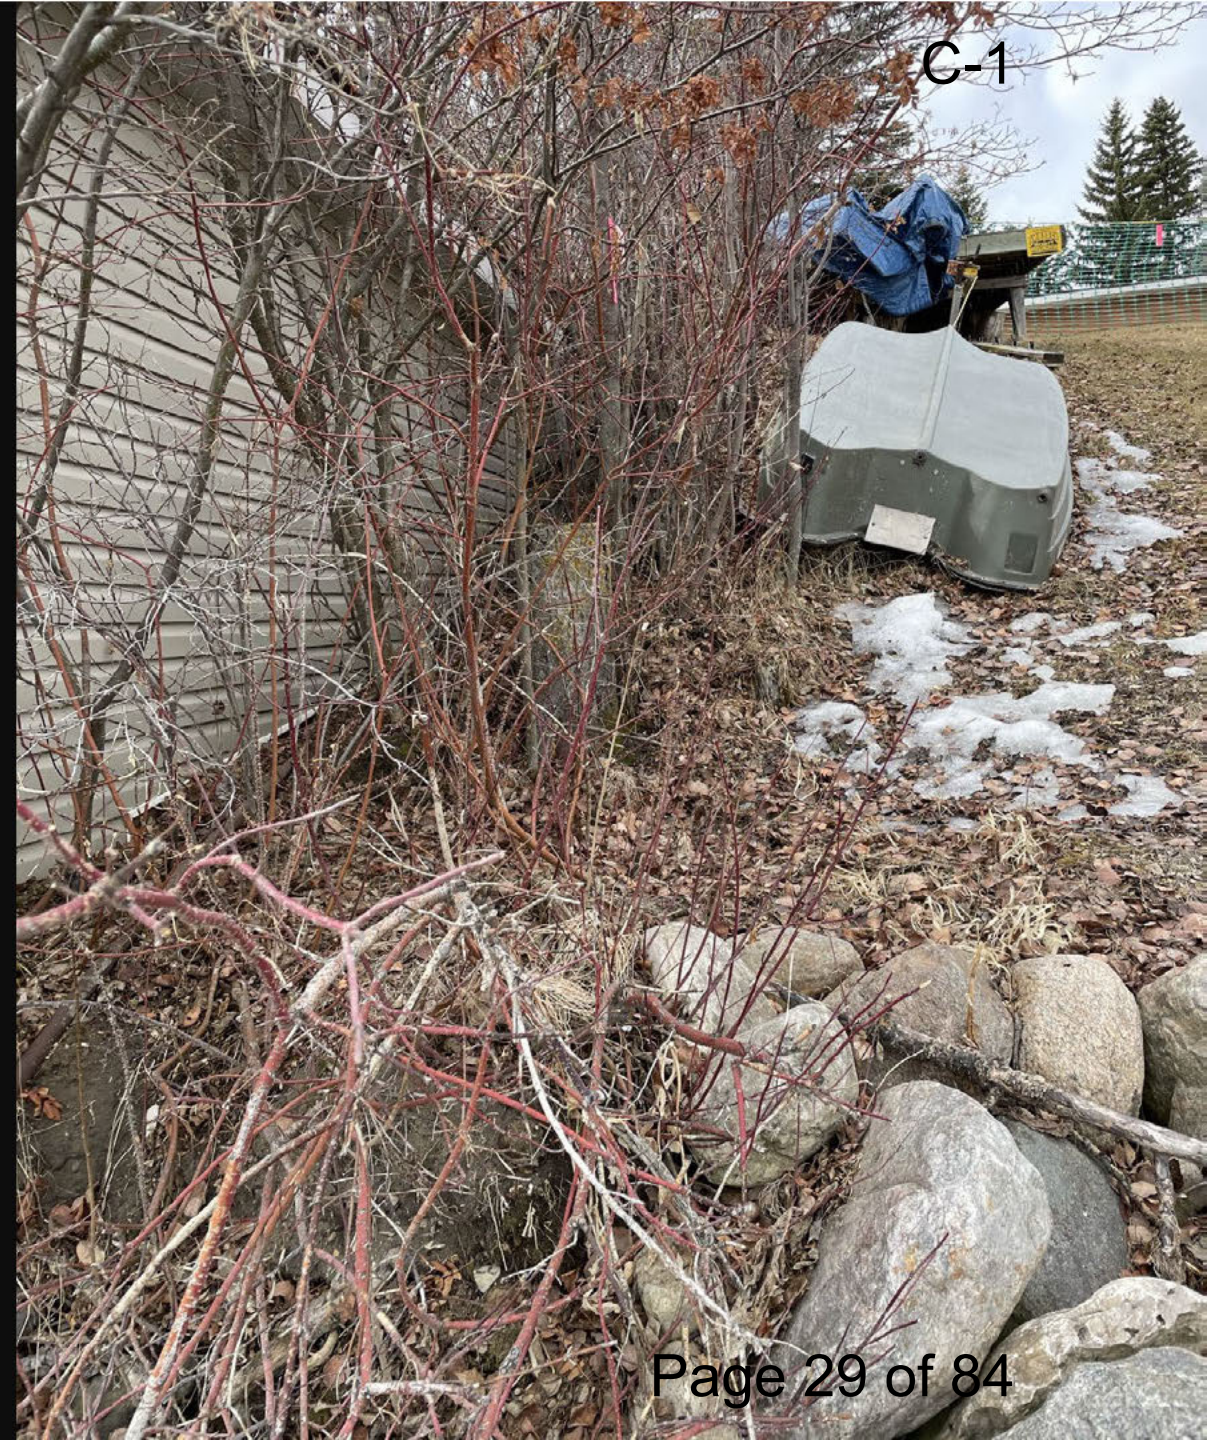
This is the lot to the south side and it is tiered with retaining walls and about a 4-to-1 slope.

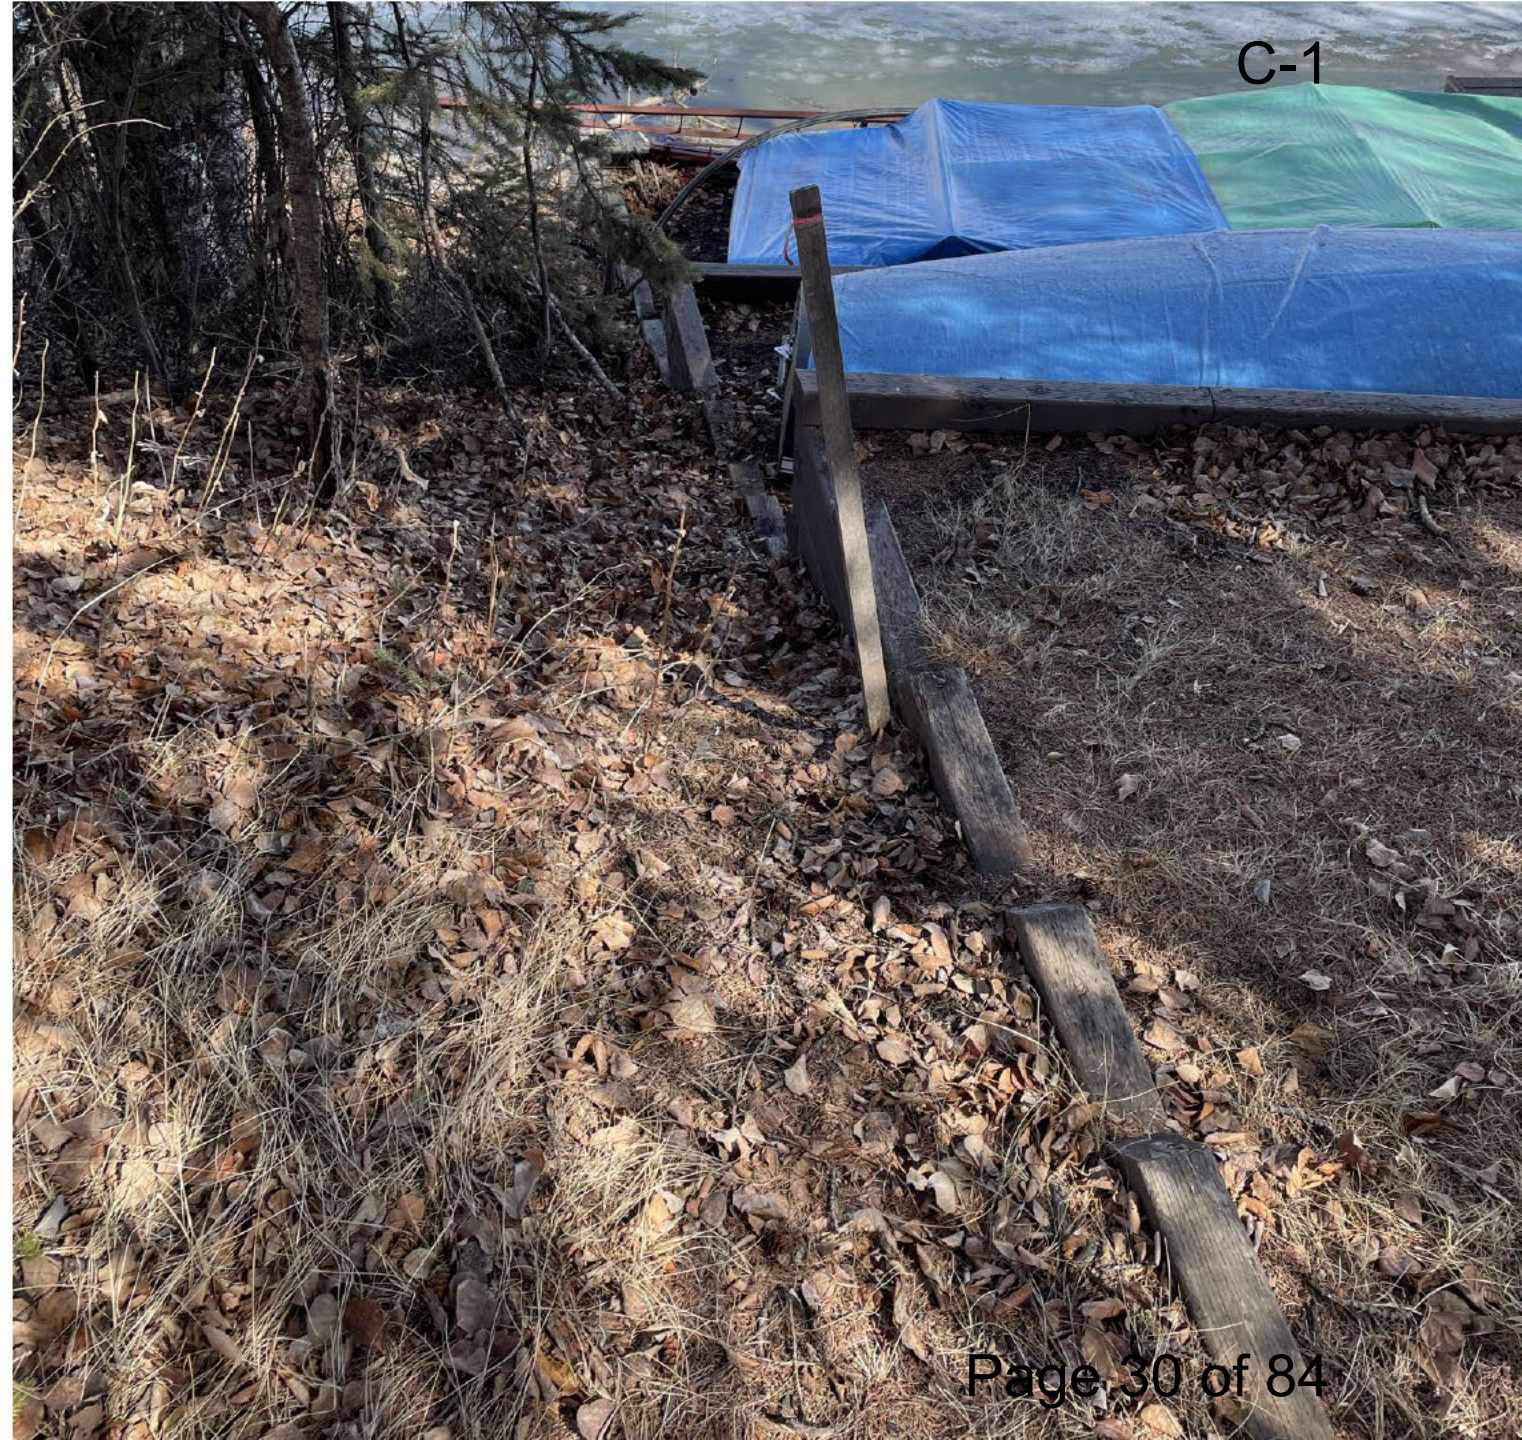
Future-planned development

While all the equipment is on-site for the bank revitalization, we would like to clear the trees for the development of the house and landscaping.

A full landscaping plan and tree replacement will be submitted with the house development permit application

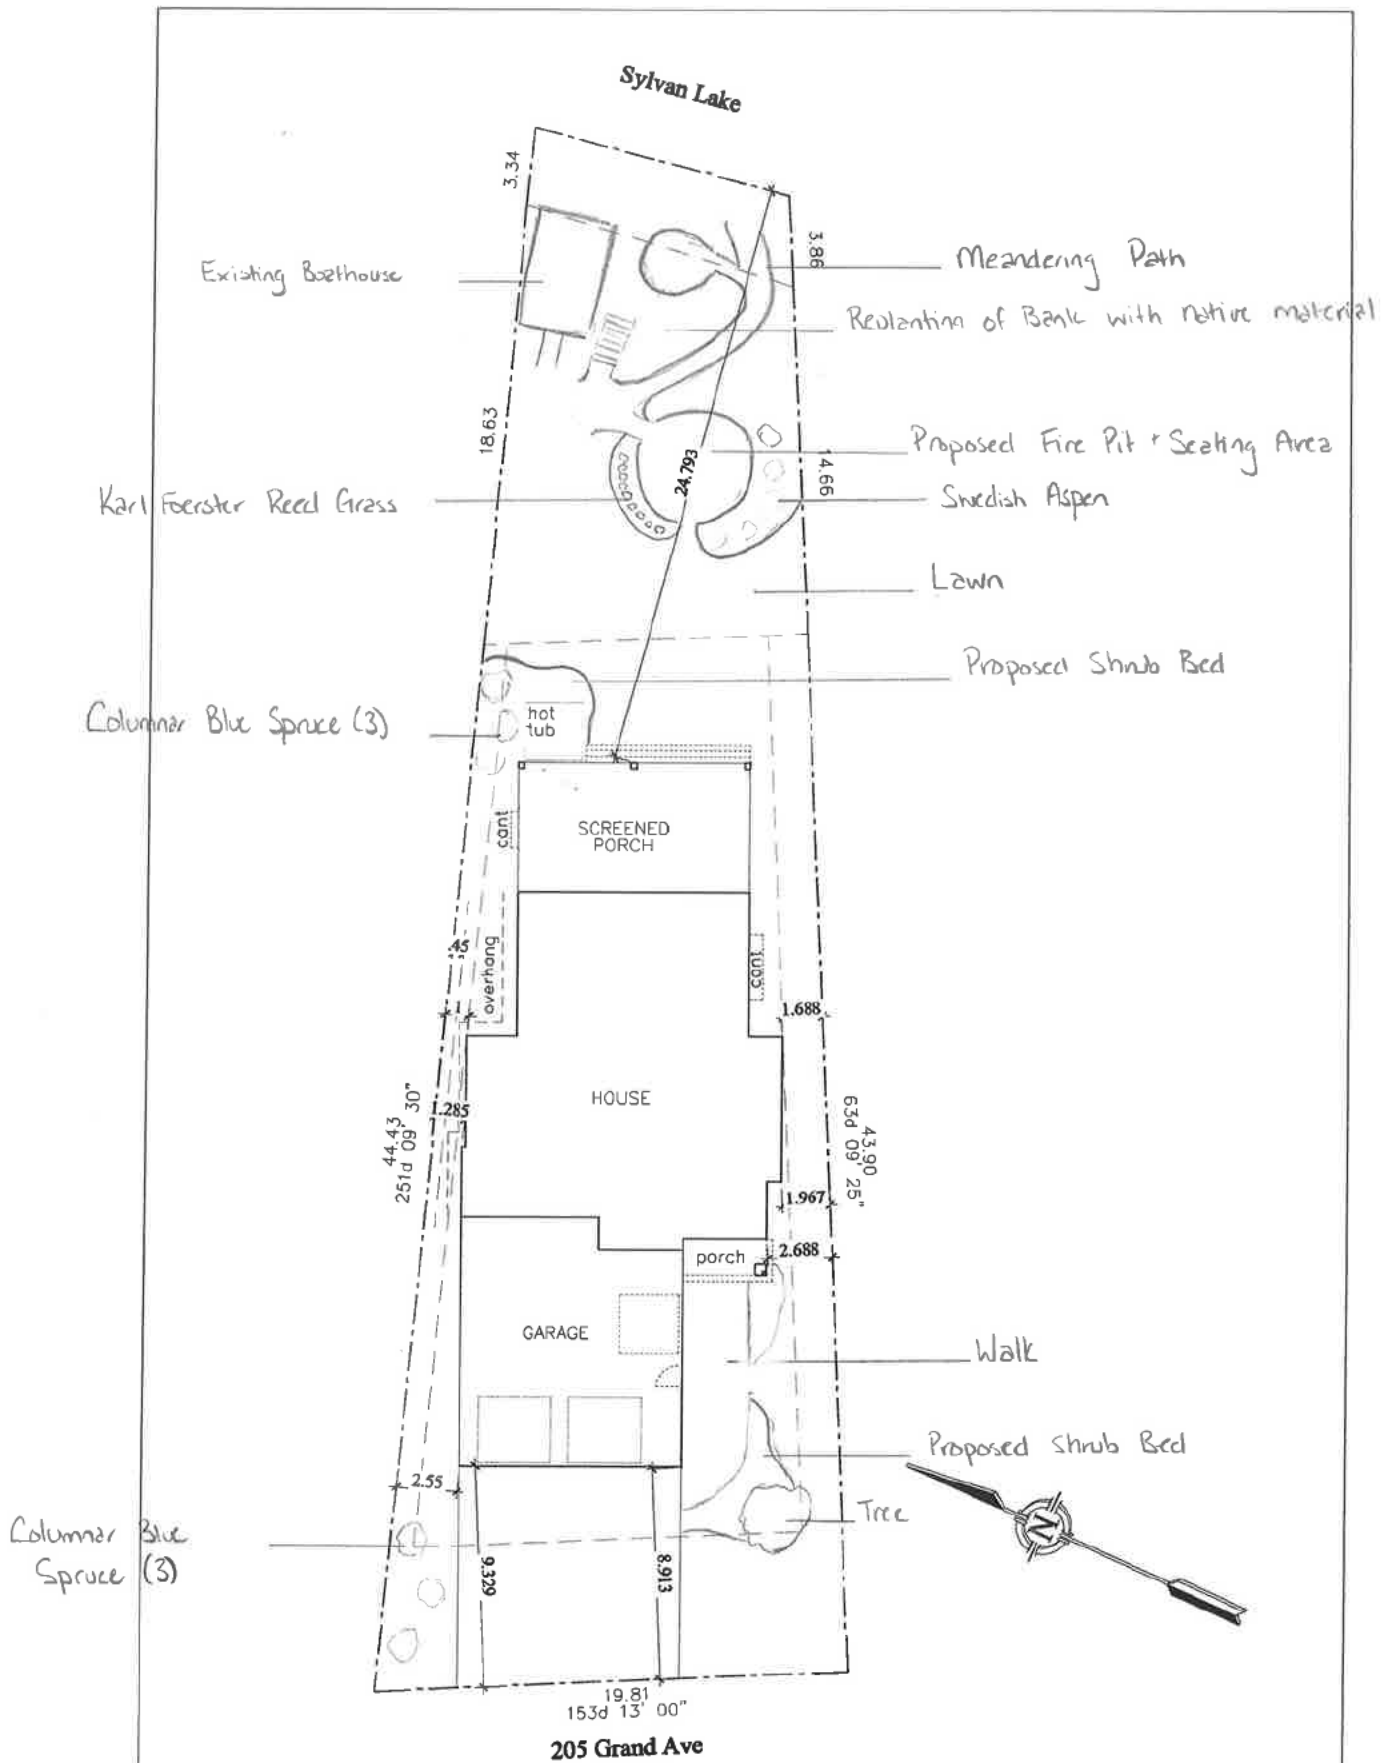
Radford Residence	205 Grand Ave, Norglenwold, AB	Lot 13 Block 02 Pl# 2206 KS
LOT AREA: 981.190 m²	BLDG. AREA: 322.246 m²	LOT COVERAGE: 32.84% DATE: June 8, 2021 SCALE: 1:200
