**MUNICIPAL PLANNING COMMISSION AGENDA
SUMMER VILLAGE OF NORGLNWOLD
SUMMER VILLAGES ADMINISTRATION OFFICE
JULY 9, 2021 @ 9:00 A.M.**

Summer Village of Norglenwold – Municipal Planning Commission**July 9, 2021****Agenda Item****205 Grand Avenue (Lot 13, Block 2, Plan 2203KS)****Development Permit Application****Background:**

GEOTECHNICAL SLOPE ASSESSMENT

PARKLAND GEOTECHNICAL CONSULTING LTD.
RED DEER, ALBERTA

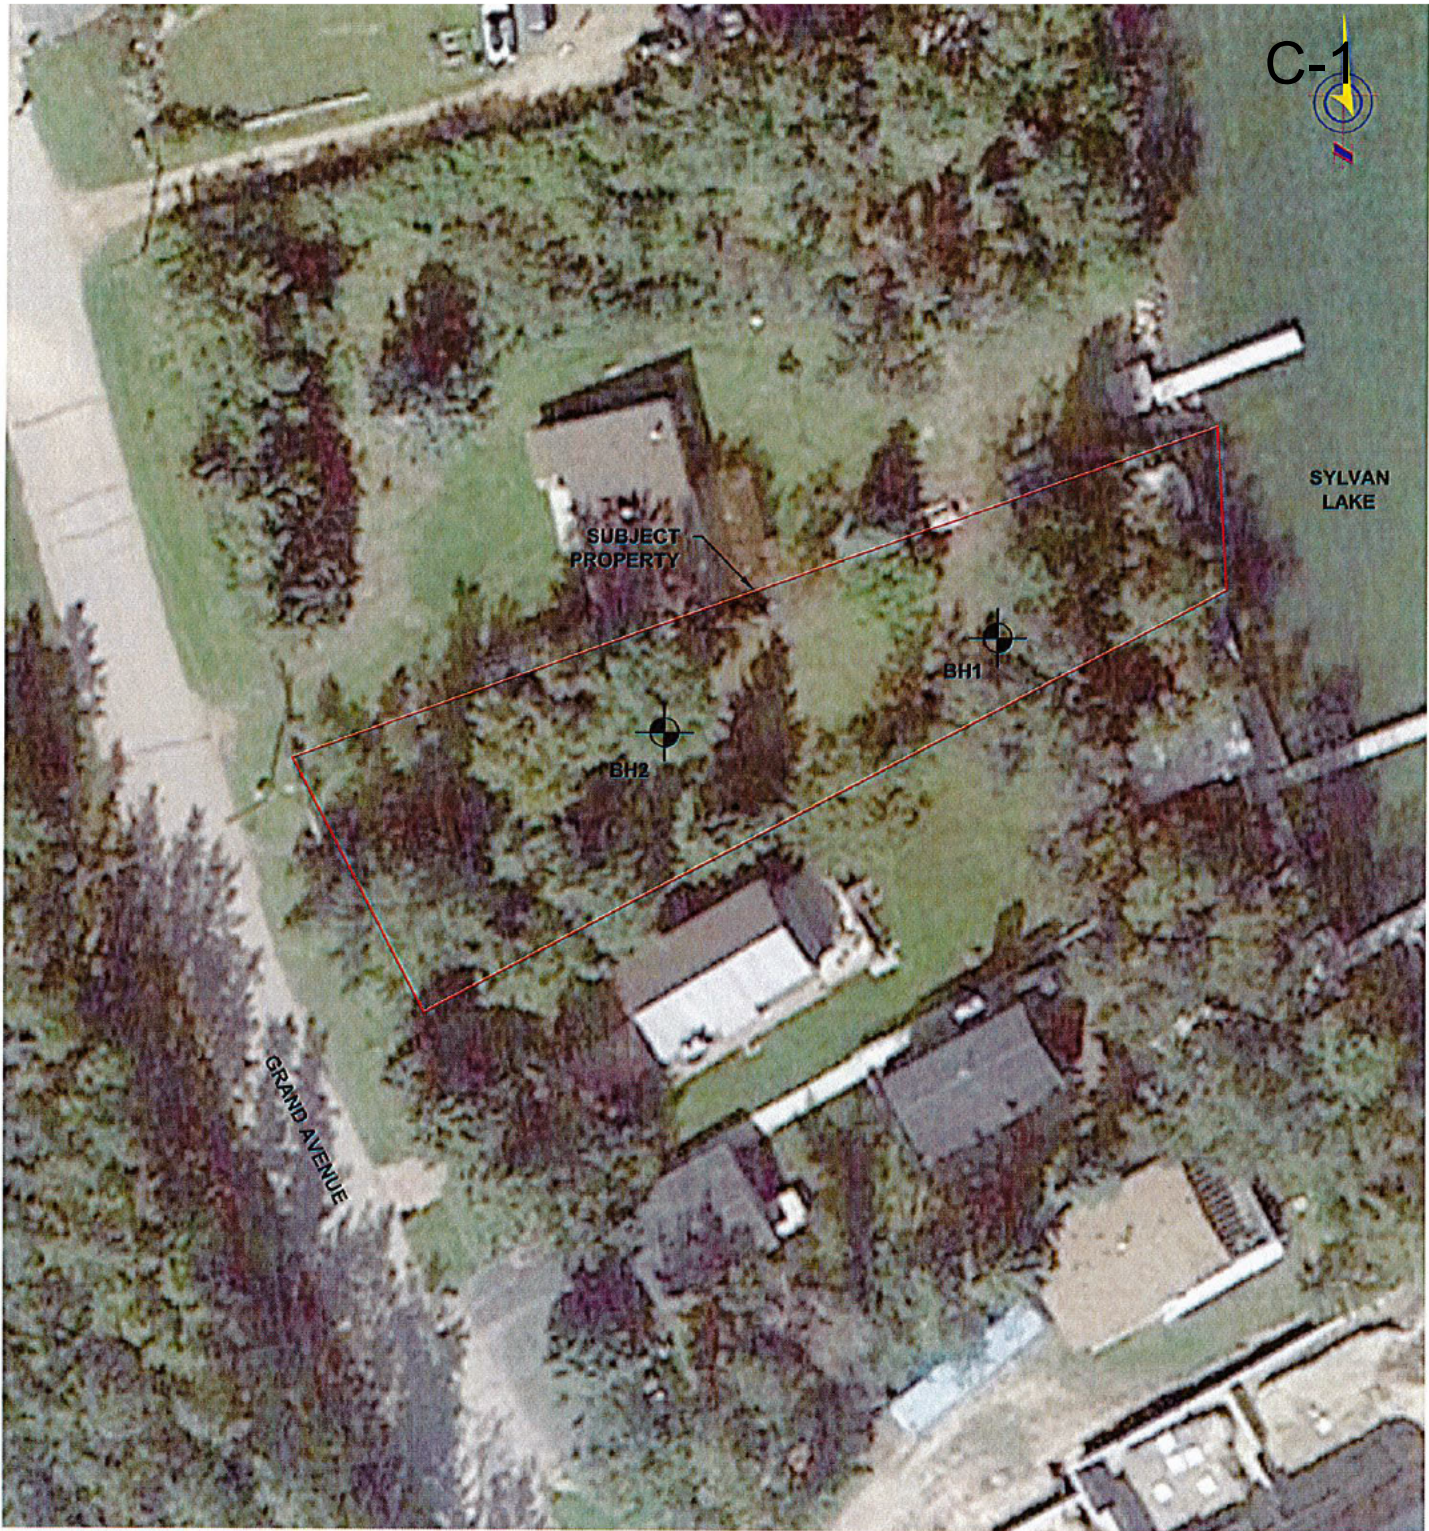
PROPOSED RESIDENCE SLOPE ASSESSMENT 205 GRAND AVENUE, NORGLNWOLD, ALBERTA			
			DRAWN: NC	CHKD.: BL	REV #: 0	DATE: JUNE 2021
			SCALE: 1:500	JOB NO. RD7303-07		DRAWING NO. FIGURE 3

NOTE: AERIAL PHOTOGRAPH OBTAINED FROM GOOGLE EARTH, DATED AUGUST 22, 2015.

On May 24, 2021, a site inspection was completed and two boreholes were drilled at the property. Borehole locations are shown on the Site and Aerial Plans, Figures 2 and 3. The following sampling and testing procedures were followed during the field program:

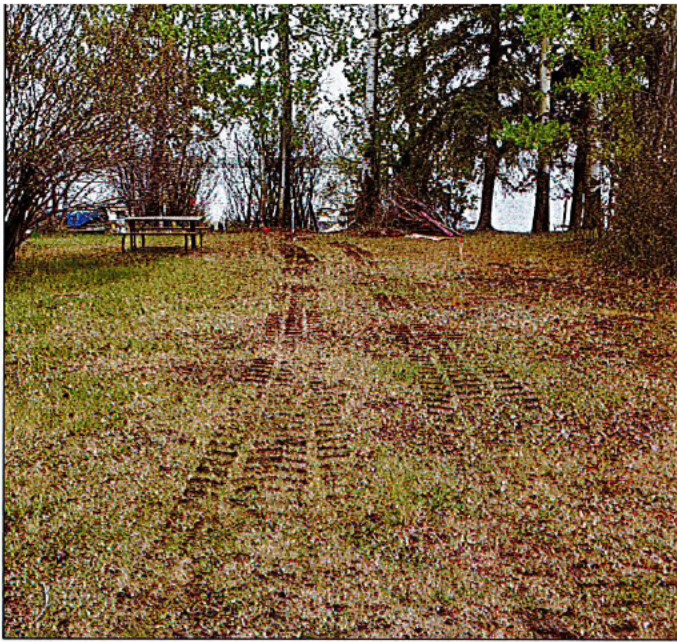
PHOTOGRAPH 1: SHOWS BH1 AND SUBJECT PROPERTY, FACING EAST

The lake slope is about 4 m high with an elevation of about 940.6 m at the crest and 936.6 m at the toe near the lake. The grade of the slope ranged from about 1.4 to 5H:1V with a typical grade of 2.5H:1V. The slope face was vegetated with mature birch trees, bushes, and native prairie grasses. The south side of the slope had a small stairway built onto the slope face. A small shed was also located on the lower slope face, about 0.5 m above the toe. The slope had been previously cut to create a relatively flat platform for the shed. Photographs of the site are shown on Figure 4.

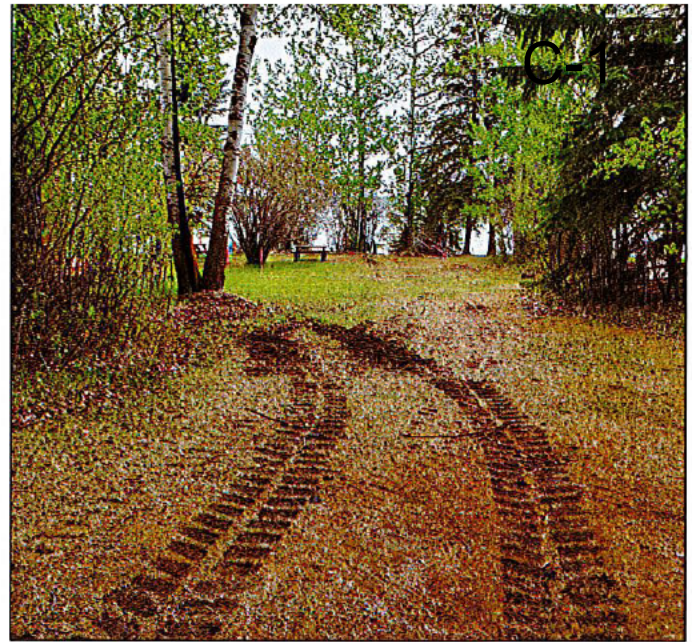
PHOTOGRAPH 2: SHOWS SUBJECT PROPERTY, TAKEN FROM GRAND AVENUE, FACING EAST

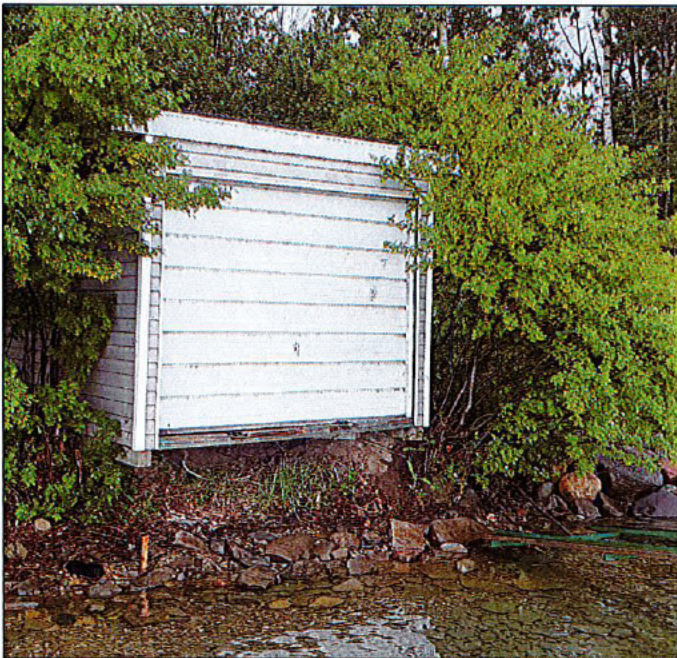
PHOTOGRAPH 3: SHOWS BOATHOUSE SHED AT TOE OF SLOPE, FACING WEST

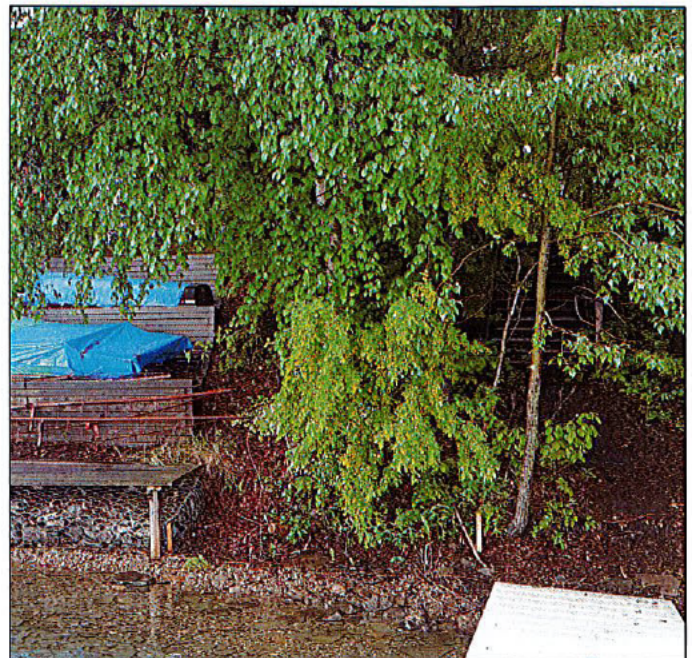
PHOTOGRAPH 4: SHOWS TOE OF SLOPE, STAIRWAY AND NEIGHBOUR PROPERTY TO THE SOUTH, FACING WEST

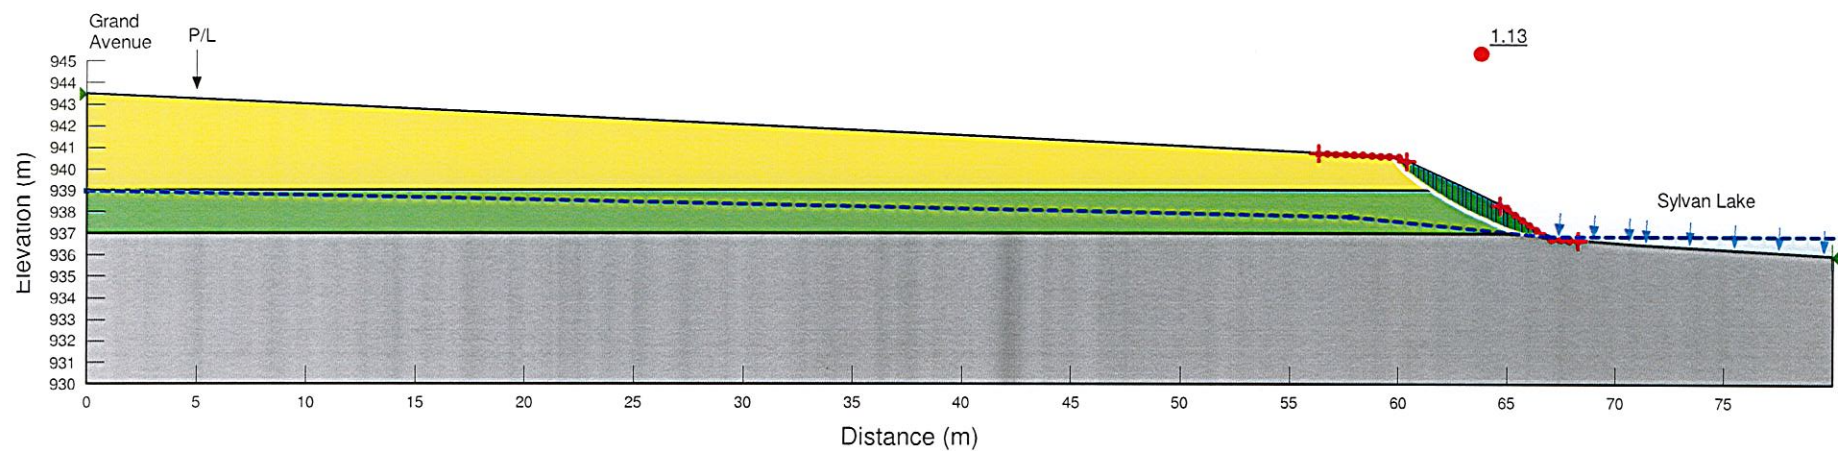
Color	Name	Unit Weight (kN/m³)	Cohesion' (kPa)	Phi' (°)	Piezomet Line
■	Residual Bedrock	20	2	22	1
■	Till	19	0	27	1
■	Weathered Bedrock	21	10	25	1

Global Stability - Existing Slope	
	JOB NO.:	RD7303-07 205 Grand Ave
	DATE:	06/08/2021
		B1

The slope profiles for the site were based on survey data collected by Base Surveys Inc. and as shown on the Contour Plan, Figure 2. A representative profile was taken through the slope on the south side of the lot. Briefly, the side slopes range from about 1.4 to 2.1H:1V, with slope height of about 4 m. The proposed slope reconfiguration was modelled by holding the toe of the slope at the lake and reducing the slope grade to 4H:1V.
